Drop Test Performance of A Medium Complexity Lead-Free Board After Assembly and Rework

P. Snugovsky, J. Bragg, E. Kosiba, M. Thomson, B. Lee, R. Brush, S. Subramaniam, M. Romansky
Celestica International Inc.

Abstract

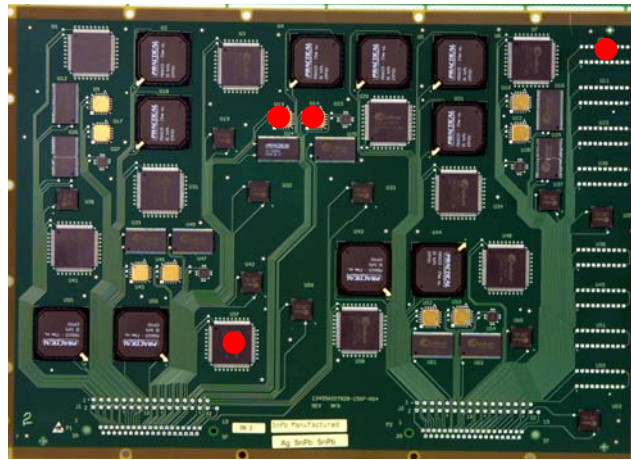
Figure 4: Location of Non-BGA Component Resistance Failures

Although 477 non-PBGA components were drop tested, only 4 had any increase in net resistance after 20 drops (see Figure 4). The 4 non-PBGA components with electrical failure had the following rework histories:

- Board SN 84, CLCC-20, U14 was **not** reworked
- Board SN 85, TQFP 144, U57 **was** reworked **once**
- Board SN 85, PDIP-20, U8 **was** reworked **once**
- Board SN 86, QFN-20, U15 **was** reworked **twice**

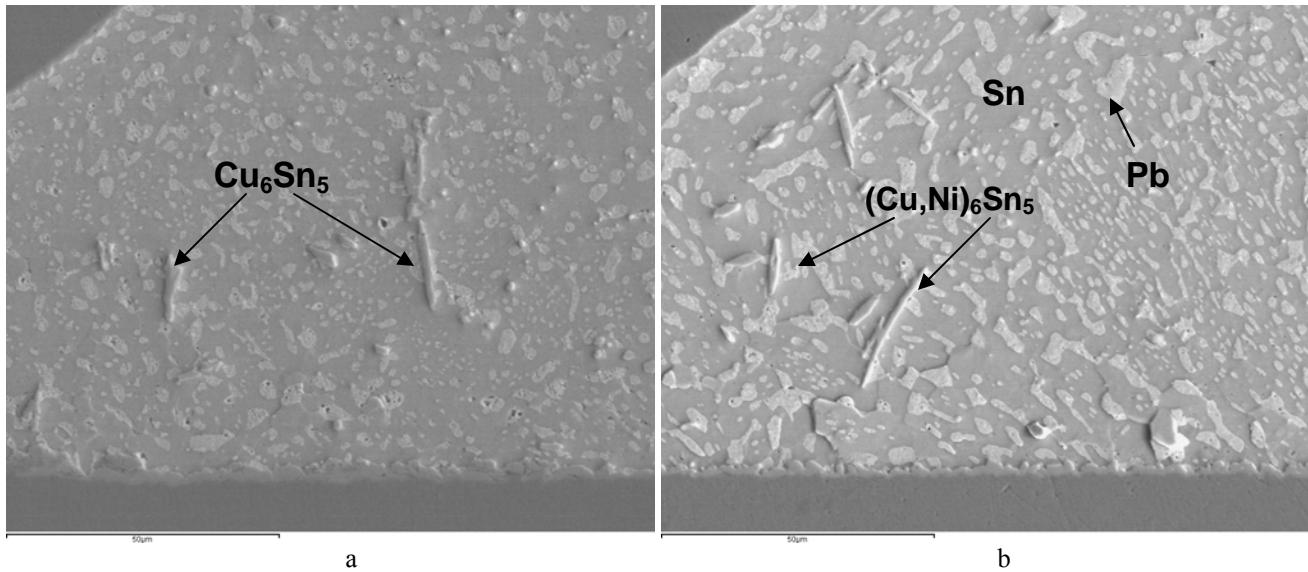
The Pb-free leaded components were reworked with SnPb solder. As expected, the SnPb microstructures of all reworked joints were quite different from that of the as-assembled Pb-free parts. After 1X rework the joints had a SnPb eutectic structure with some primary intermetallic crystals (Figure 6). EDX analysis showed that these intermetallic particles were of the Cu_6Sn_5 type. Some joints also contained some Ni, particularly in the TSOP-50. The number of the primary intermetallic crystals was lower in the QFP-20 reworked joints than in the TQFP-144 and TSOP-50.

Figure 6: Typical microstructure of 1X reworked solder joints using SnPb solder, SEM, 1000X: a – TQFP-144; b – TSOP-50

A significant portion of primary intermetallic solidifies first, followed by the SnPb eutectic and depends on the primary SAC305 alloy composition. The reason for such a significant shift in composition was found in our previous study on ball grid array component rework [4]. During the pad redress step, most of the Pb-free solder left after component removal was consumed by using a Cu solder wick. The rest of the solder was heavily enriched with intermetallic particles. This remaining solder then mixed with the eutectic SnPb alloy used for rework. The excessive intermetallic particles caused a shift in SnPb solder composition from the near eutectic to off-eutectic.

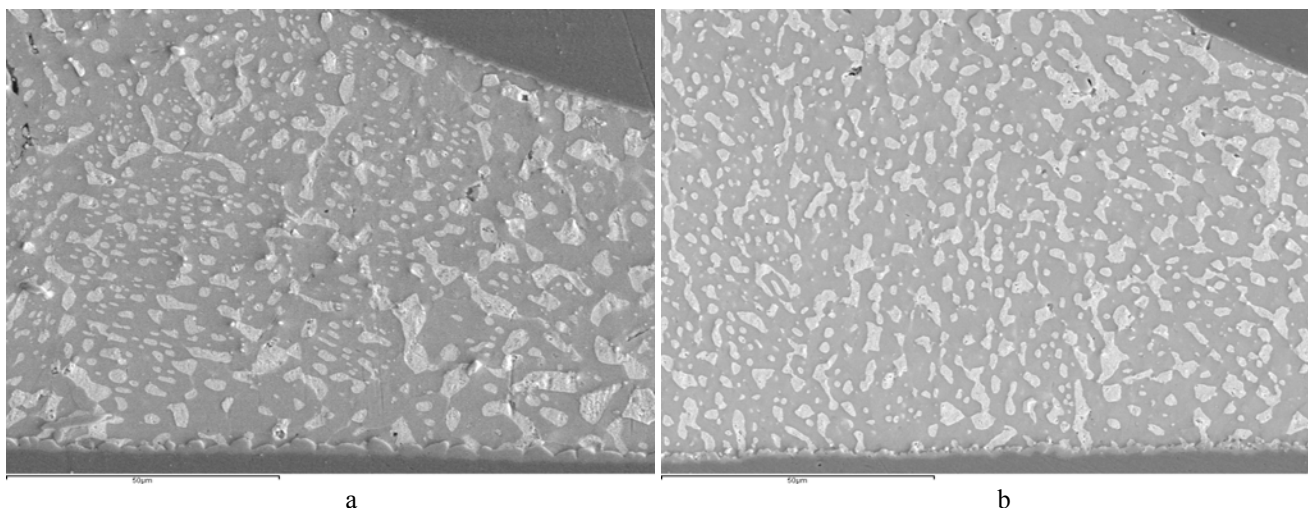
After 2X rework, the solder joint microstructure looks like that of a conventional SnPb interconnect - there are no large primary Cu_6Sn_5 crystals present in the solder joint (Figure 7)

Figure 7: Typical microstructure of 2X reworked solder joints using SnPb solder, SEM, 1000X: a – TQFP-144; b – TSOP-50

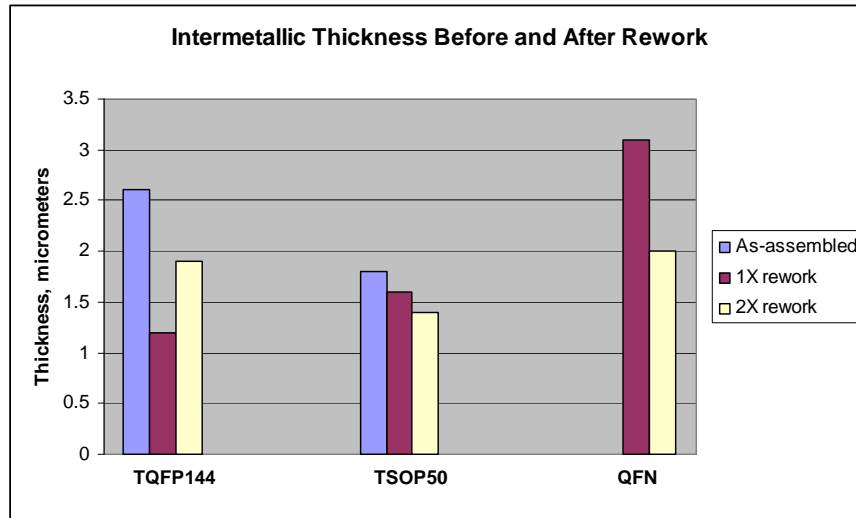
The intermetallic layer formed between the Cu pads and solder in reworked SnPb joints was thinner than in SAC305 as-assembled joints (Figure 8). In the TSOP-50 and QFN it was even thinner after 2X rework. Such a phenomenon was observed by the authors previously and may be explained by dissolution of the intermetallic layer in a fresh solder placed during rework. However, this thickness of intermetallic should not affect the quality or reliability of the solder joints.

Figure 8: Intermetallic thickness before and after rework.

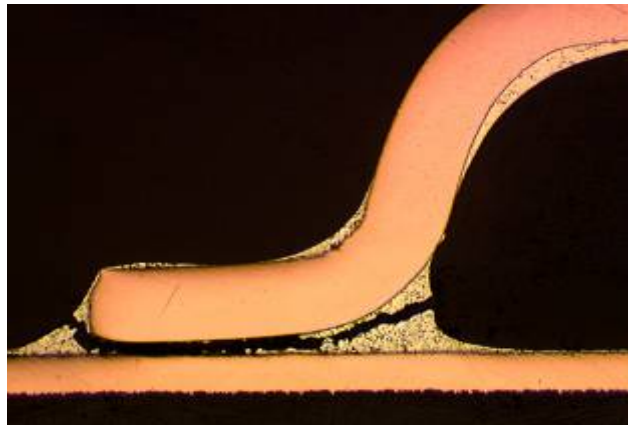
Pad cratering occurred in all package types (CLCC-20, QFN-20, TQFP-144, TSOP-50) but was less prevalent in the TQFP-144 in which pad cratering was observed on only one out of nine dye-and-pry samples and was not at all found through cross sectioning. This is likely due to the structure of the part, which has compliant copper leads on all four sides, ensuring efficient stress distribution. However, in one part, the lead was found to fail through the solder in a fatigue failure mode (see Figure 9).

Figure 9: Fatigue failure of TQFP-144 with 1x rework as seen through cross sectioning

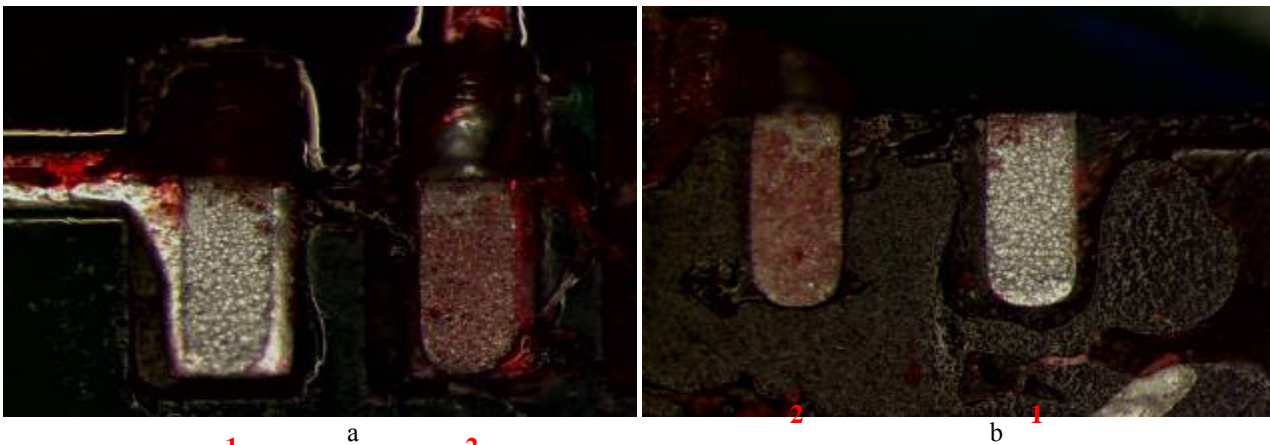
Partial solder joint cracks and pad cratering were both observed on the QFN-20 part, at approximately the same frequency. For example, in Figure 10, pin 1 of this QFN-20 package, shows some evidence of dye penetration through the bulk solder, indicating that a fracture was present prior to prying the component from the board. The penetration covers less than 25% of the solder surface near the top edge of the joint. Pin 2 shows almost complete dye penetration across the whole pin. The fracture appears to include the intermetallic surface.

Figure 10: Dye and Pry results of a QFN-20 showing dye penetration through the bulk solder: a- board side; and b- component side

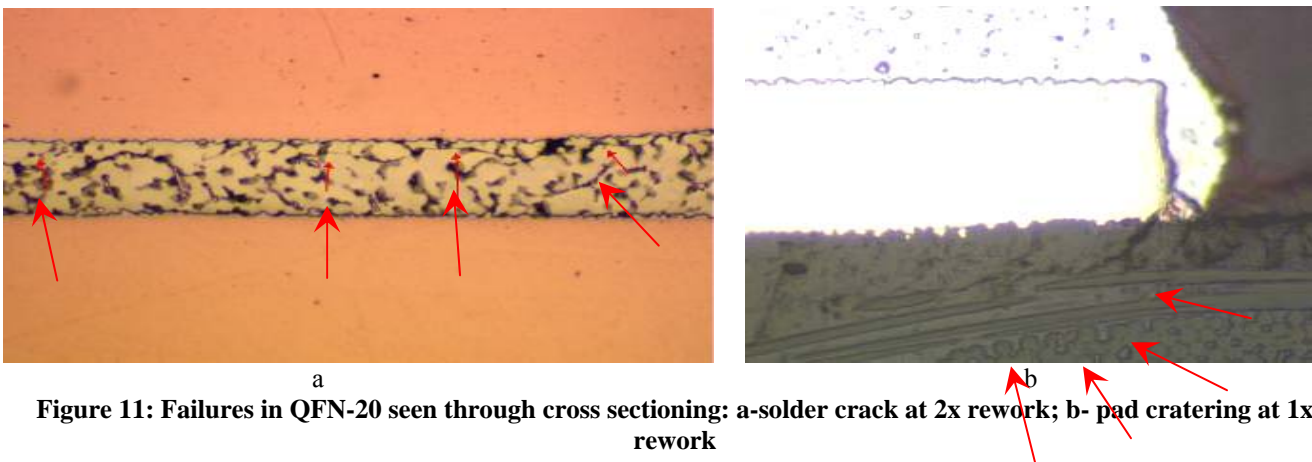
Figure 11: Failures in QFN-20 seen through cross sectioning: a-solder crack at 2x rework; b- pad cratering at 1x rework

Figure 11 shows cross sections which reveal both a fine crack through the bulk solder and pad cratering in a QFN-20 package.

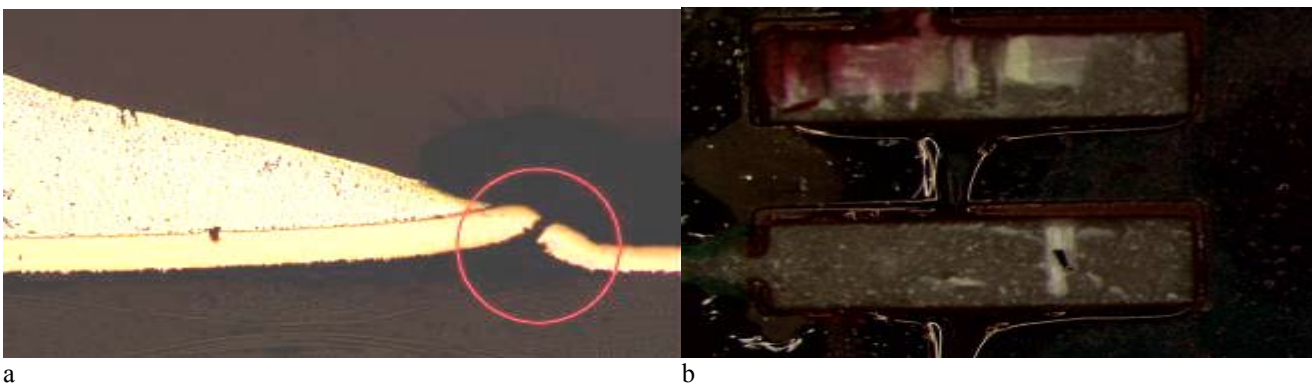
Both the CLCC-20 parts tested and most of the TSOP-50 parts destructively analyzed show some degree of pad cratering. The cross section in Figure 12(a) illustrates an example of cratering that resulted in a broken trace which can explain the corresponding electrical failure. Figure 12(b) shows the typical pad cratering of a CLCC-20 viewed through dye-and-pry testing.

Figure 12: Pad cratering seen on CLCC-20 through: a- cross sectioning; b- dye-and-pry
