# Double Reflow-Induced Brittle Interfacial Failures in Pb-free Ball Grid Array Solder Joints

This paper describes and characterizes electrically intermittent, brittle interfacial solder joint failures in a Pb-Free ball grid array (BGA) subjected to two reflow cycles. The failed BGA is a 1.27 mm pitch, perimeter array with a body size of 31 mm and SAC305 (Sn3.0Ag0.5Cu) solder balls. Due to the presence of several surface mounted daughter card modules on the non-BGA side of the board, the BGA-side of the printed circuit assembly was soldered first. In effect, this constraint put the BGA components atypically on the bottom-side during the second reflow. The solder joint failures were characterized with metallographic cross sectional analysis using optical microscopy and scanning electron microscopy. The failure mechanism and possible root cause are discussed in terms of the combined impact of stress induced by component and board warpage and the lower inherent strength of the solder joint near the melting and solidification temperatures. The primary objective of this work is to document this new case of Double Reflow failure to enable a heightened awareness of the failure mode. Thes

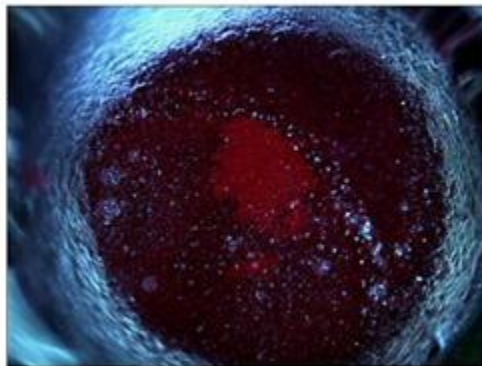
Because the suspect failure locations were not in the outer rows, defect detection by visual and low magnification optical inspections was unsuccessful. Transmission X-ray inspection also was unable to detect or image failed solder joints. This is expected since conventional, transmission X-ray cannot resolve fine cracking or thin planar defects that are nothing more than air gaps in the soldered structure. Consequently, destructive analyses were initiated starting with the “dye and pry” (DnP) method. The primary objective of the DnP was to determine if the solder joint had failed at the package or PCB side of the joint. Dye intrusion occurred at multiple solder joint sites and dye penetration was observed at the component side of all failed solder balls. A typical image of a DnP surface is shown in Figure 2. It was also noted that incomplete dye penetration was observed at some locations. This is indicative of either incomplete initial solder joint formation or subsequent cracking through only a fraction of the intended attachment area.

**Figure 2: Optical photomicrograph of a failed solder ball surface after dye and pry (DnP) testing. This surface has fractured between the solder ball and BGA package pad (at the component side). The red color on the surface is from the dye intrusion that occurs prior to the mechanical prying.**

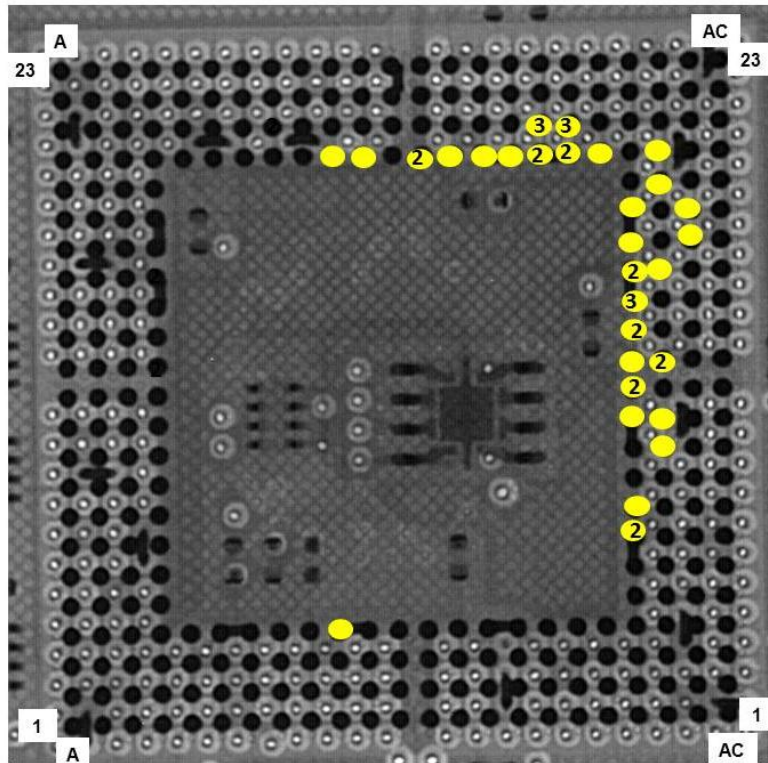
Figure 3 shows the a composite map of failure locations taken from three different Component A samples overlaid on a low magnification transmission X-ray micrograph of the package ball pattern. The pattern of indicted sites is asymmetric within the package array and is concentrated in proximity to the inner row of perimeter ball array. This inner row failure signature is atypical for many of the intermittent failure modes discussed in the previous section. Those types of failures tend to manifest in the outer rows at the corner and near-corner locations that are known to be the highest stress-strain locations in BGA packages. However, exceptions to this trend can be found in PBGA packages that exhibit certain specific warpage signatures. It is common for warpage stresses to be high at the corner sites, but they also can be high in the die shadow region due to the high CTE mismatch between the package laminate and the silicon die.

Asymmetric failure patterns (Figure 3) are not common but when they occur, they are believed to result from mechanically or thermally unbalanced structures in either the PCB or the package that affect CTE and thermal transfer.

**Figure 3: Failure location map from dye and pry test data overlaid on a transmission X-ray image of BGA Component A. This map is a composite of failures for Component A taken from three different PCBAs.**

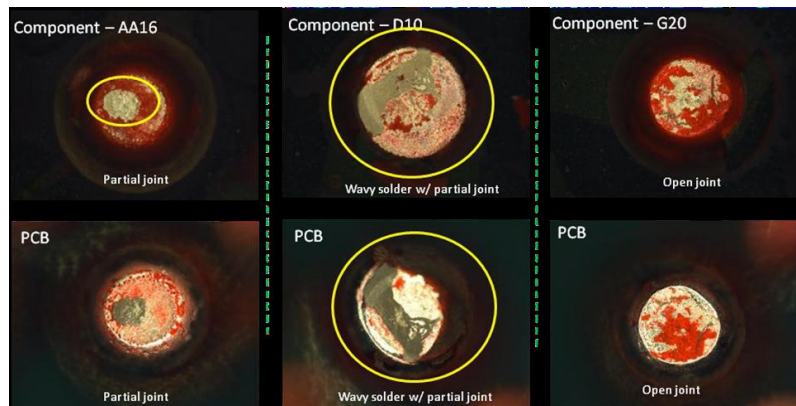
Additional optical and SEM micrographs of failed solder joints at the component side are shown in Figures 4 and 5. These failures initially were diagnosed as ball de-wet or ball drop, pointing to the assembly process as the root cause.

**Figure 4: Optical photomicrographs of various fracture surfaces after DnP testing.**

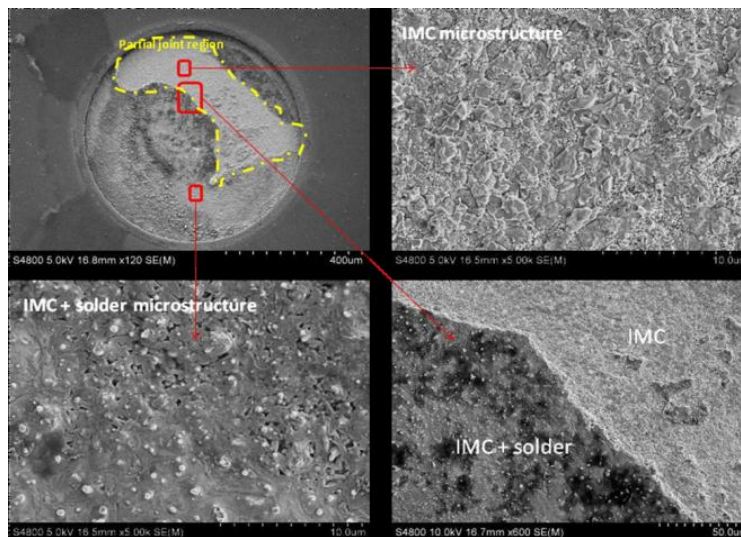
**Figure 5: SEM micrographs of various fracture surfaces after DnP testing.**

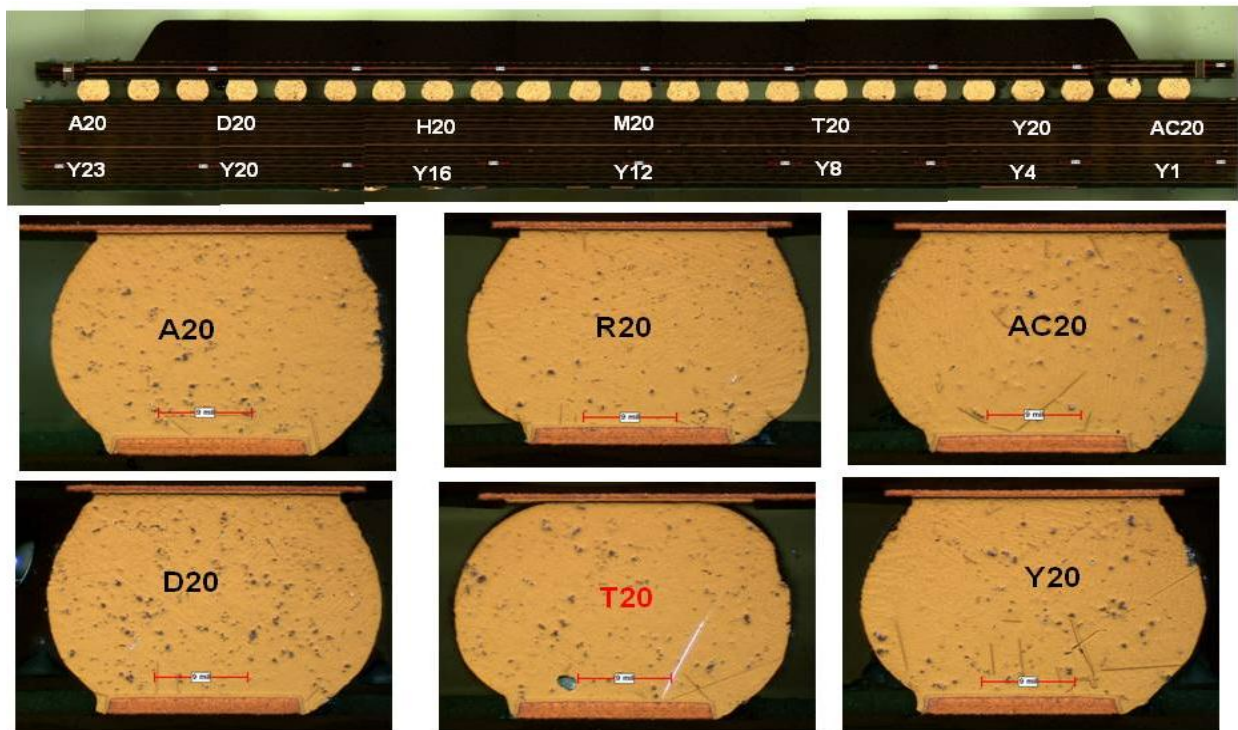
Destructive cross sectional metallographic analysis was performed to provide more detailed and conclusive failure mode data. The analysis was conducted on Component A from a PCBA sample that contained suspected solder joint opens. The component was cross-sectioned row by row analysis and optical photomicrographs were obtained for multiple solder balls in each row. The photomicrographs in Figure 6 show cross sections of multiple solder balls across Row 20 in Component A. Row 20 is one of the inner rows of the “picture frame” of the BGA package pin diagram. The solder joint at pin location T20 does not appear to be formed properly and this is confirmed in the higher magnification image in Figure 7.

**Figure 6: Multiple metallographic cross sections of solder balls in Row 20 of Component A.**

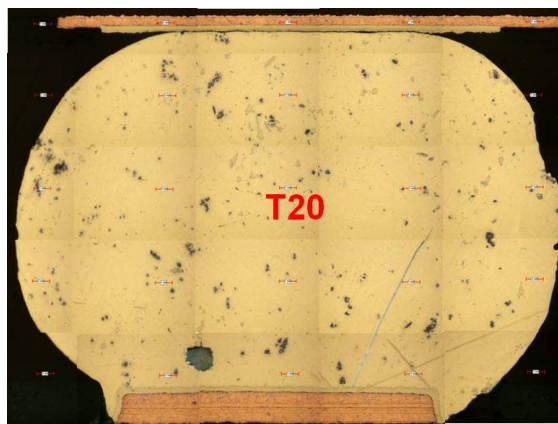
**Figure 7: A higher magnification photomicrograph (initial magnification 500X) showing a defect that appears to be de-wetting at package location T20 in Component A. The ball seems to be detached from the package pad.**

The initial indication from the high magnification photomicrograph in Figure 7 is that the T20 ball was never soldered to the BGA pad. At this low magnification, the solder ball appears to be de-wetted from the pad. However, an even higher magnification photomicrograph presented in Figure 8 shows that the T20 solder joint actually separated from the BGA pad at the interface between the Ni-Sn (nickel-tin) intermetallic compound (IMC) and the bulk solder. The presence of an IMC layer and a relatively small amount of solder on the PBGA pad confirm the solder ball had been previously attached to the pad. The spherical curved surface of the bulk solder at the perimeter of the solder ball also indicates melting. By all indications, the soldering reaction was successful initially and the solder joint was formed properly. In contrast, the top of the solder ball is flat and parallel to the component pad indicating that a brittle solder joint fracture occurred. This failure signature is consistent with that reported in the Double Reflow references [1, 2] and it is suggested that a similar failure mechanism can account for the T20 solder joint failure. As the solder joint temperature increased and approached the melting temperature during the second reflow, mechanical stress in the PCBA structure was sufficient to induce a brittle fracture at the IMC interface just prior to reaching the melting temperature. The source of the stress could be a combination of CTE mismatch in the package as well as PCB and component warpage. The subsequent melting of the solder ball moments later in the reflow process accounts for curved surface of the solder ball and de-wetted appearance at lower magnification.

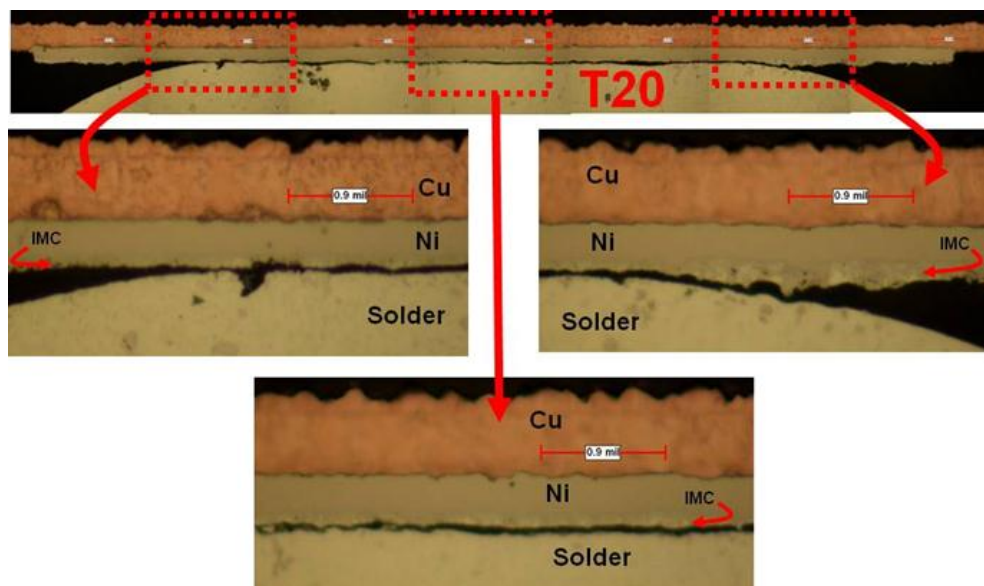
**Figure 8: Higher magnification photomicrographs (initial magnification 1000X) adjacent to the T20 BGA pad area showing evidence of a prior successful soldering reaction on the BGA pad with subsequent fracture at the interface between the IMC layer and the bulk solder.**

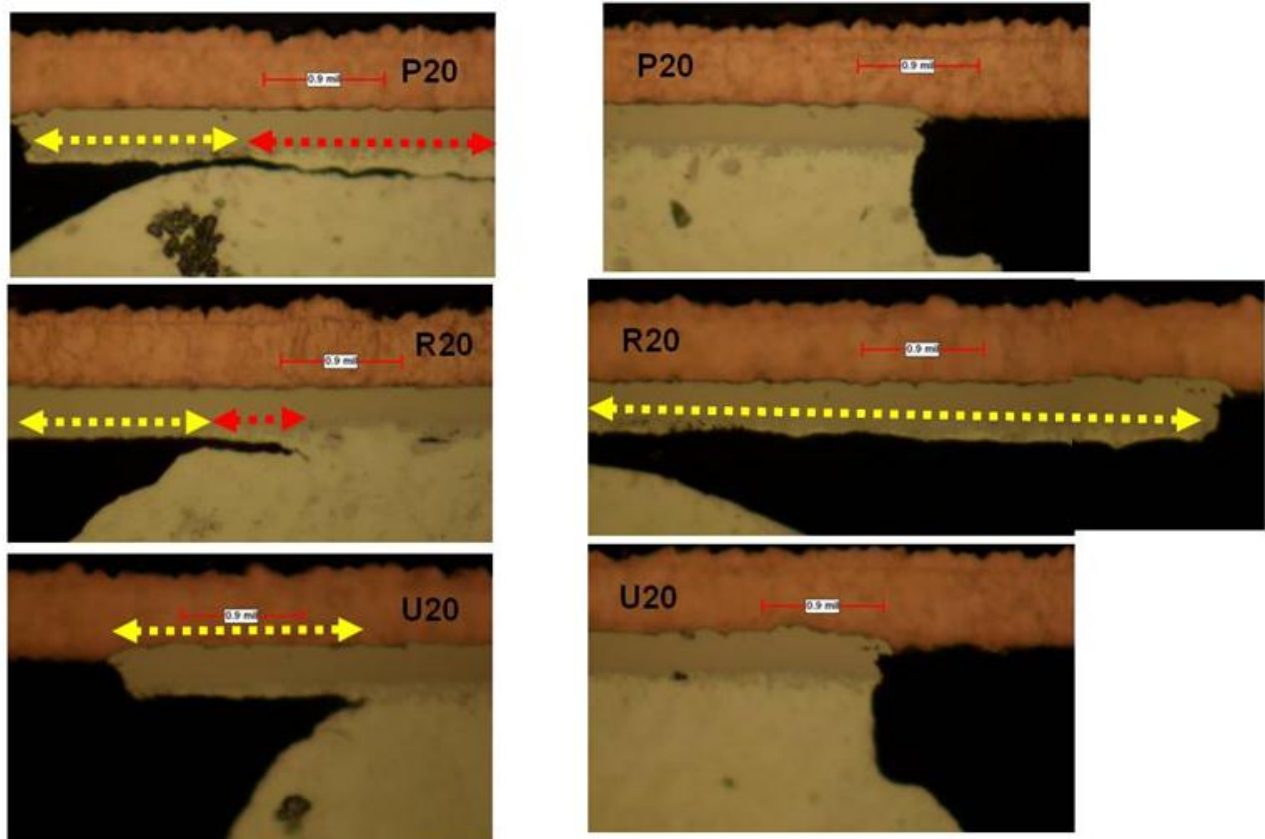
To draw a distinction between the de-wet and brittle fracture modes, the solder joint separation surfaces (interfaces) must be analyzed carefully. In addition to the total separation shown in the T20 solder joint, the three adjacent balls P20, R20 and U20 shown in Figure 9 exhibit similar but partial separation of the solder ball from the Ni-Sn IMC. At first glance, the separations marked by the dashed yellow lines in Figure 9 look like the solder joint de-wetting failures. However the separated areas marked by the dashed red lines in Figure 9, show clear indications of cracking or fracturing rather than de-wetting.

**Figure 9 - Magnified cross section, 1000X, of PCBA, Component A, solder balls P-20, R-20, and U-20.**

The obvious path for elimination of the failures in this design was to subject the BGA-side of the PCBA to only a single reflow pass. This corrective action was implemented successfully. The soldering of the heavy daughter card modules on the non-BGA side of the board was achieved by modifying other aspects of the assembly process.

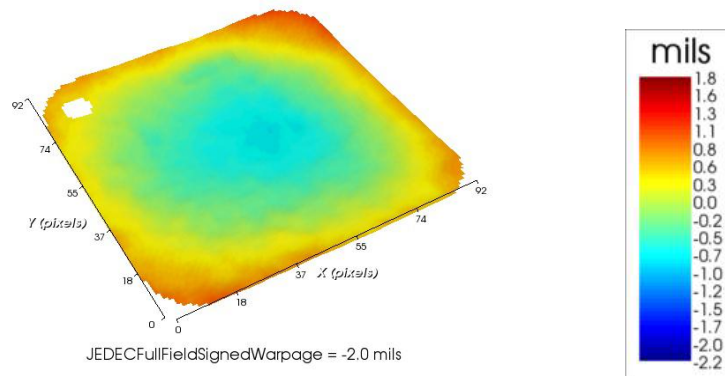
**Figure 10: A warpage displacement map across the overmolded area of Component A measured during temperature ramp up at 220°C.**

The thermal shadow Moiré data in Table 2 indicate a net displacement or warpage of Component A relative to the PCB of approximately 4 mils during heating in advance of melting or during cooling before solidification takes place (shaded Max.  $\Delta$  cells in Table 2). It must be acknowledged that there are uncertainties in interpreting these displacement measurements. First, these measurements may not reflect the component and PCBA behavior accurately as it would occur during an actual factory reflow cycle. More importantly, the amount of warpage needed to induce solder joint fracture is unknown. A similar amount of warpage can create other serious BGA defects such as head on pillow (HoP) but HoP is a completely different failure mode [6, 7].

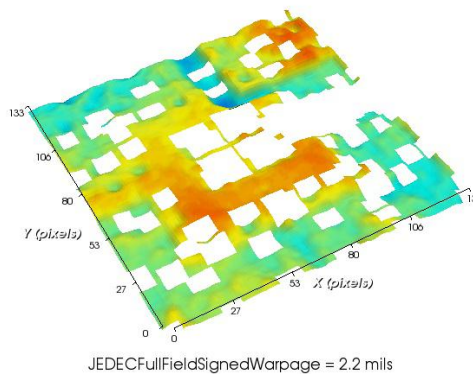
**Figure 11: A warpage displacement map for the PCB footprint matching Component A. The measurements were made during temperature ramp up at 220°C.**

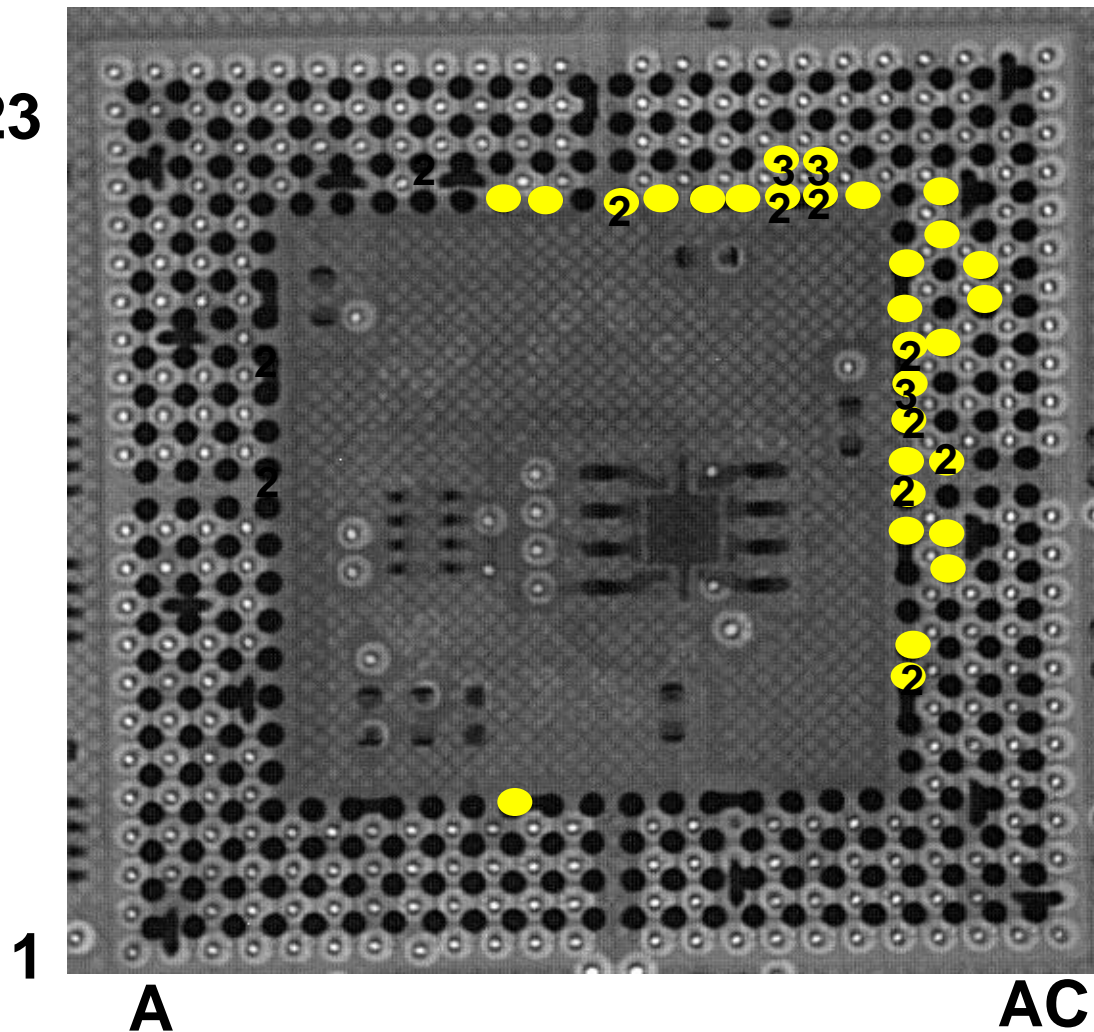
● Failure Locations

number indicates how many of 3 packages evaluated had failure, blank=1

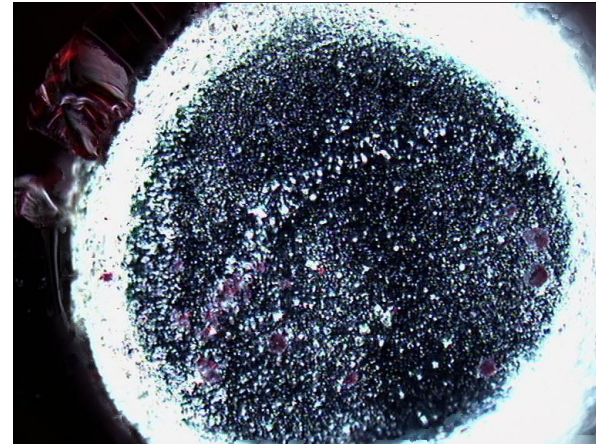
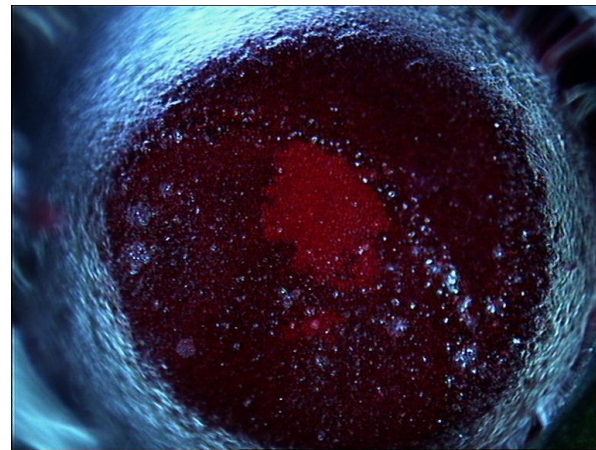
200x substrate side.

200x ball side.

\*Optical images show dye intrusion on location# AA11

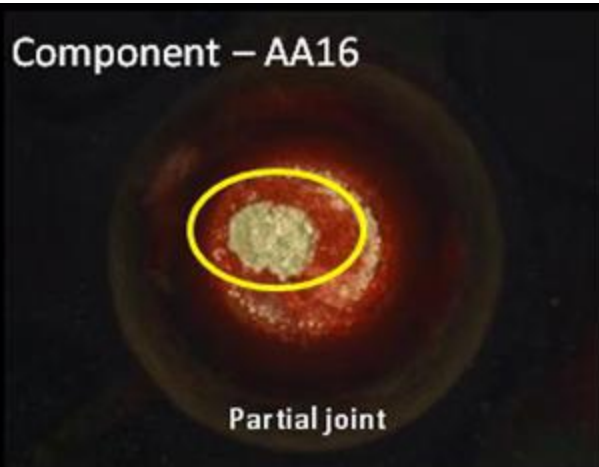
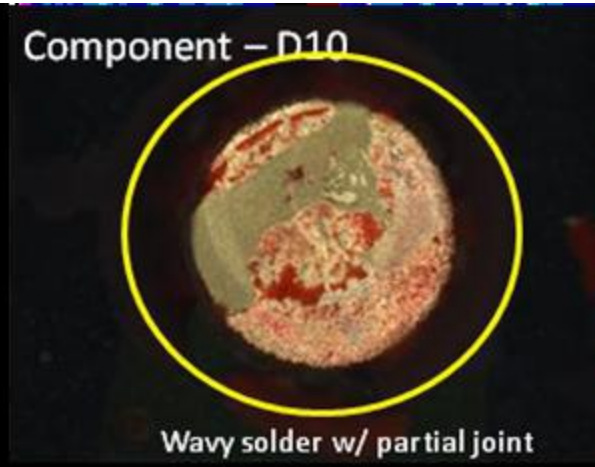
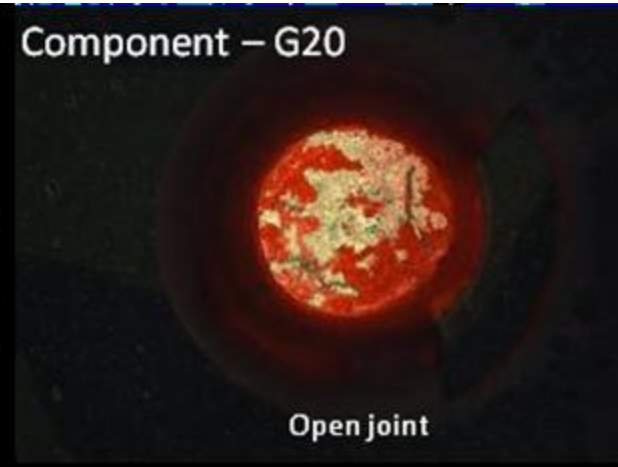
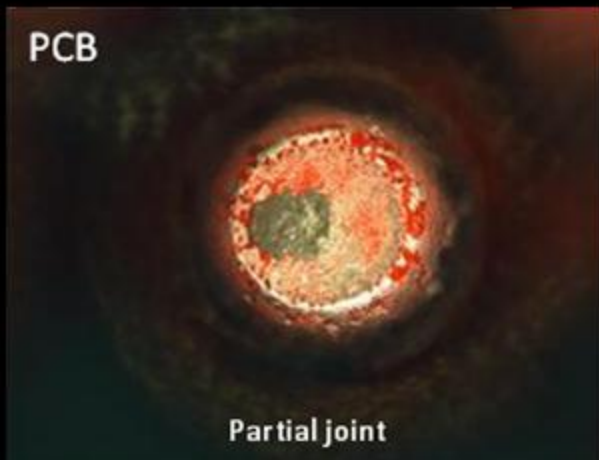
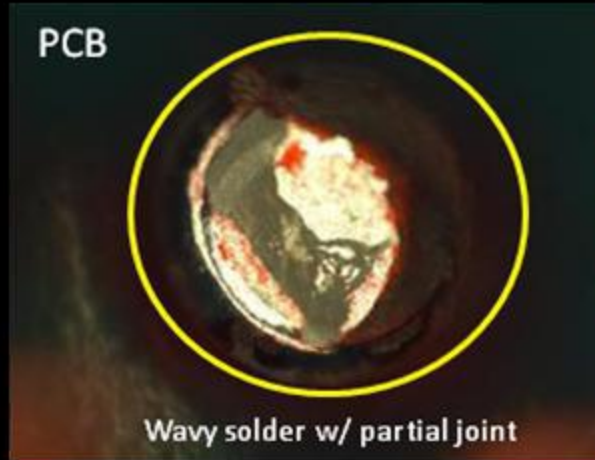
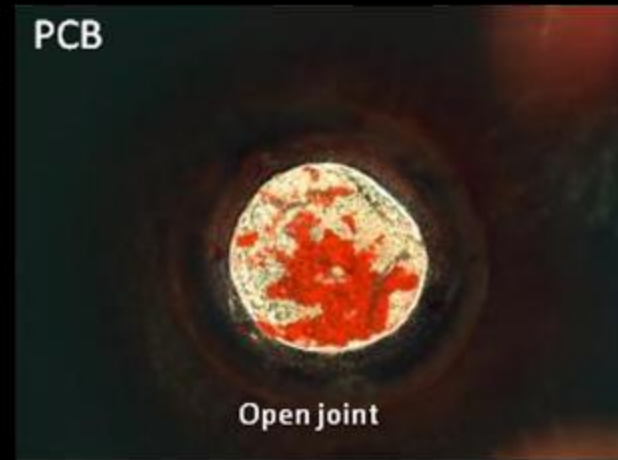
Partial and completely open solder joints were found

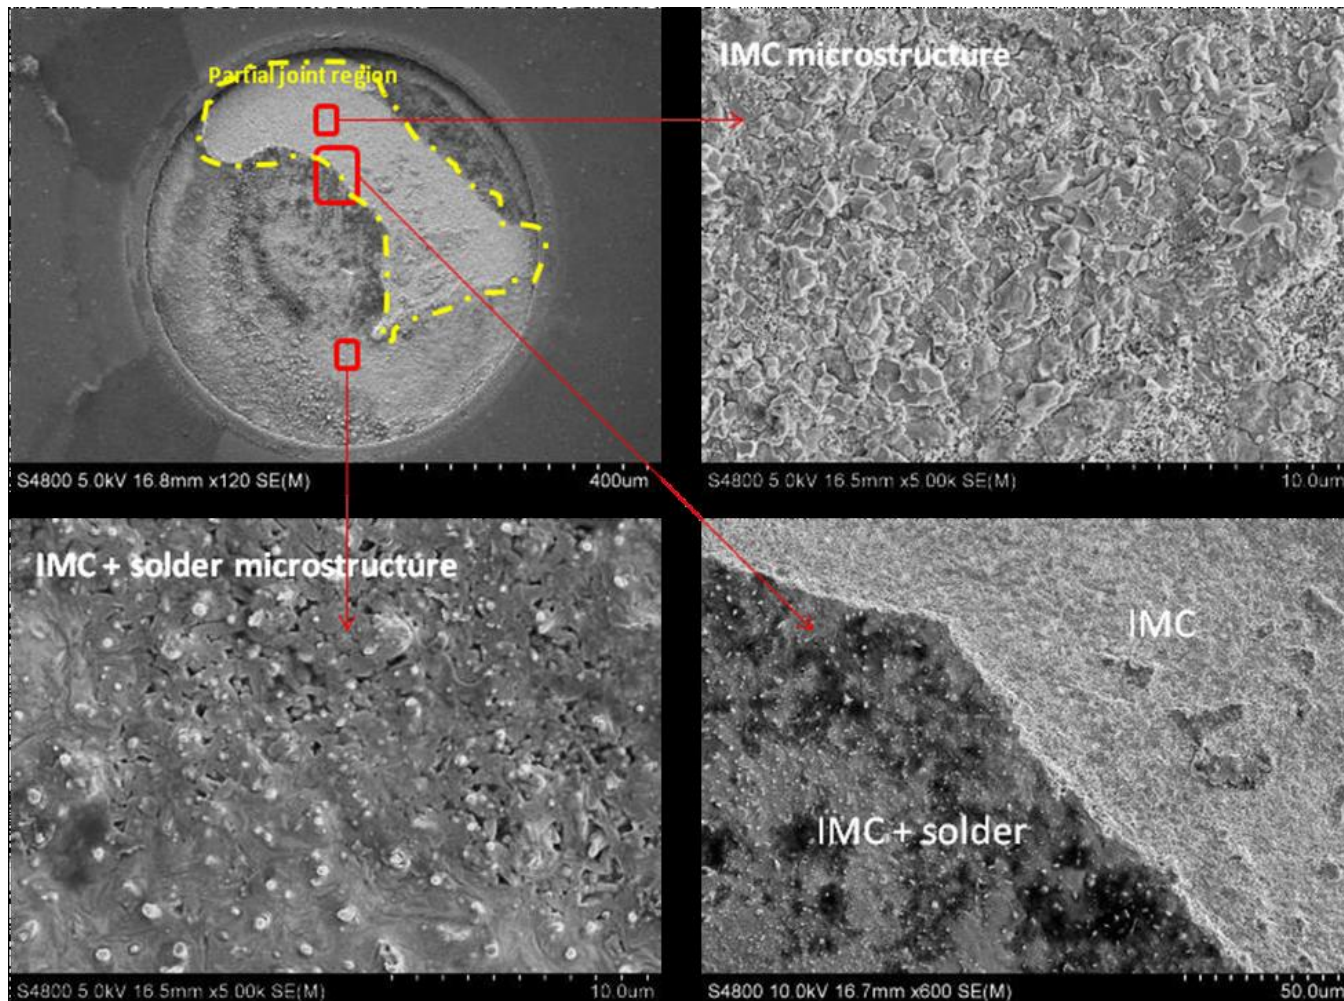
Post Dye and Pry SEM/EDX  
IMC presence at substrate pad implies ball had been attached

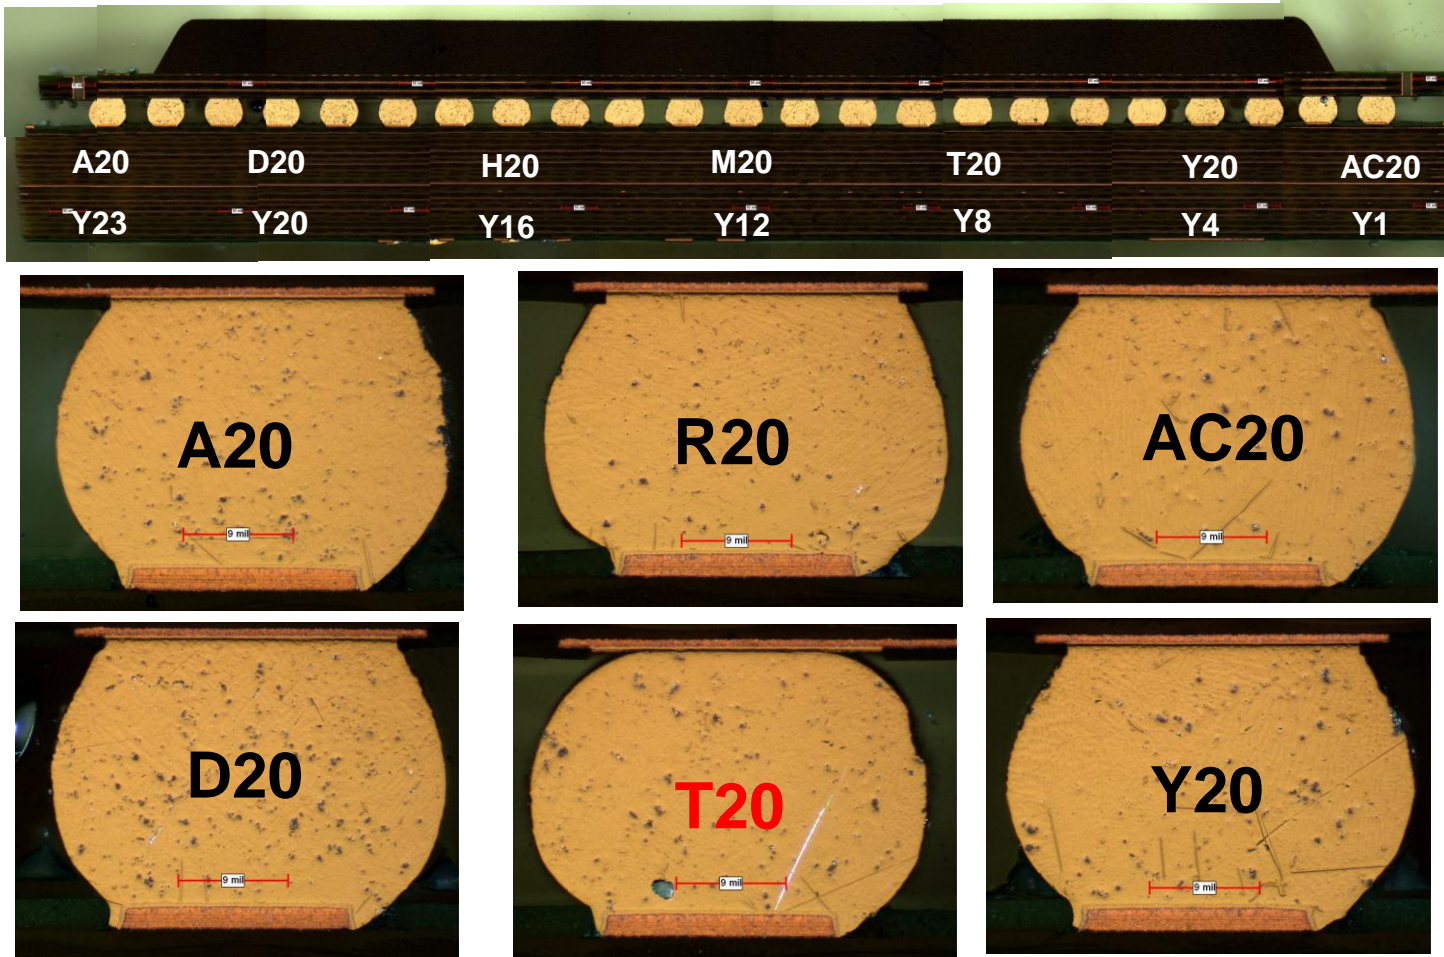
Multiple metallographic cross sections of solder balls in Row 20 of Component A.  
Note solder ball **T20** appears to be dewetted.

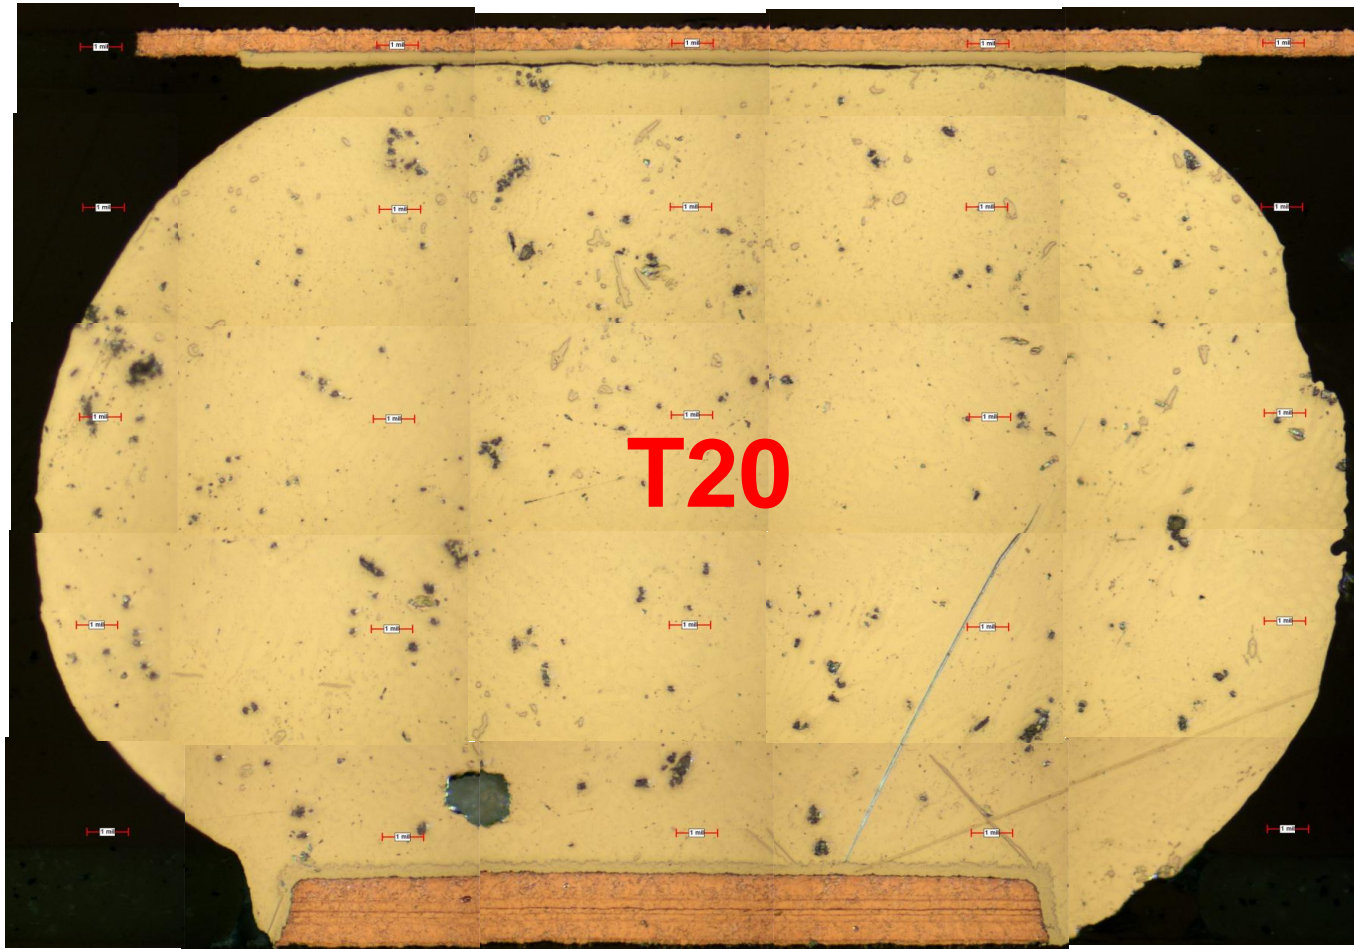
A higher magnification photomicrograph (initial magnification 500X) showing a defect that appears to be de-wetting at package location T20 in Component A. The ball seems to be detached from the package pad.

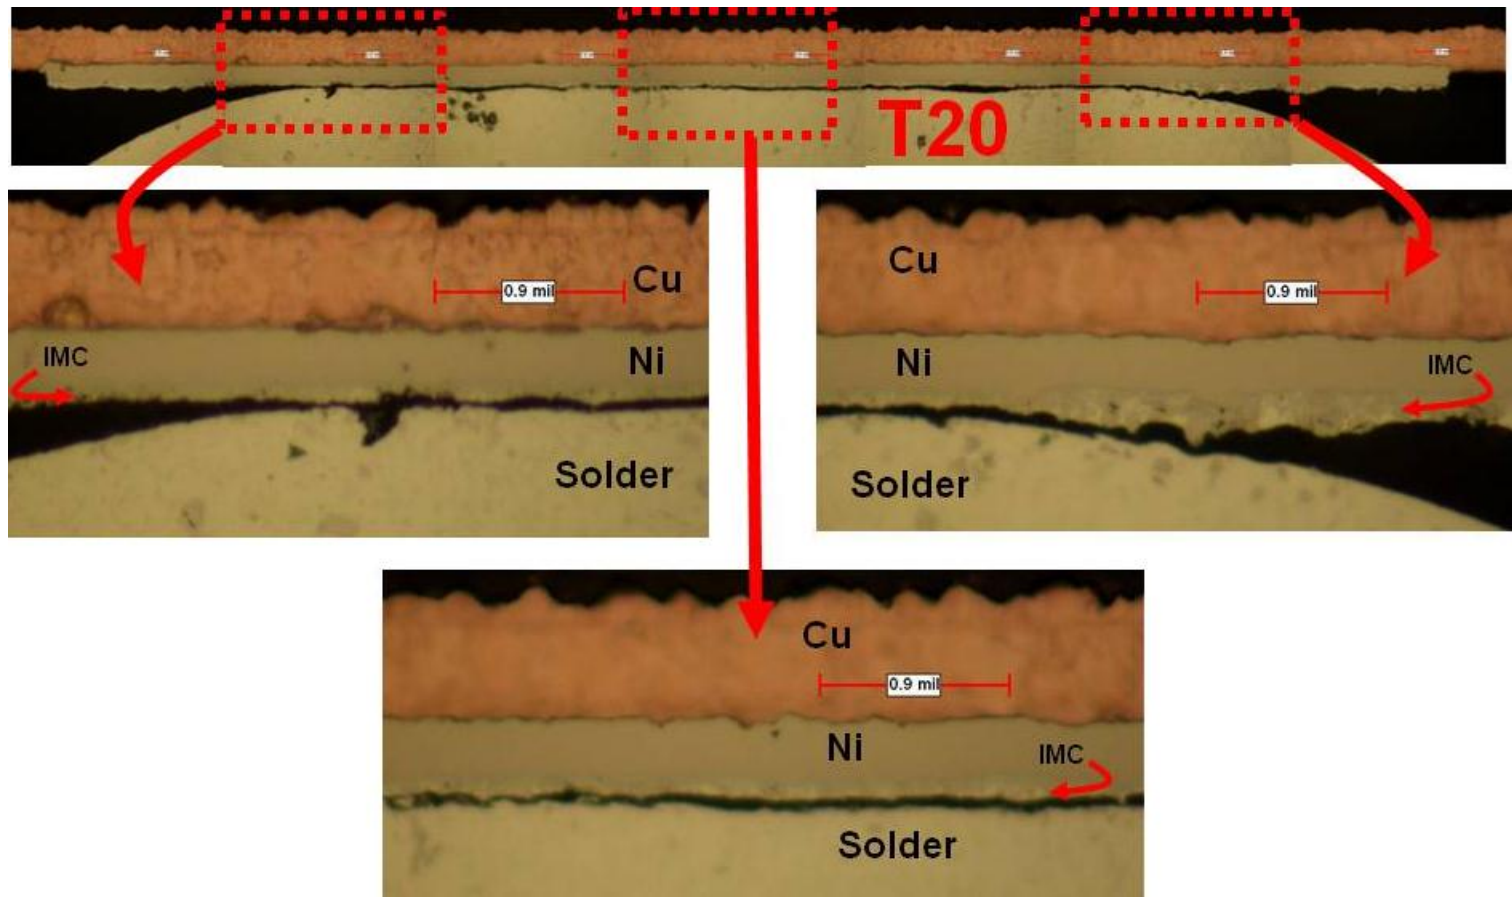
Higher magnification photomicrographs (initial magnification 1000X) adjacent to the T20 BGA pad area showing evidence of prior successful soldering on the BGA pad with subsequent fracture at the interface between the IMC layer and the bulk solder.

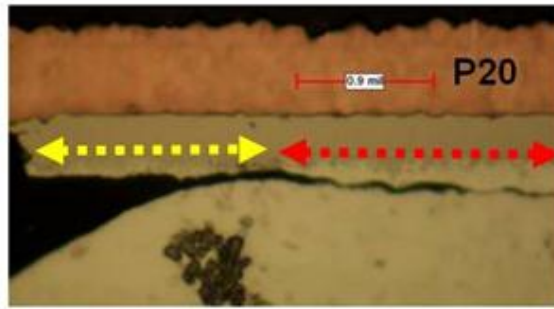
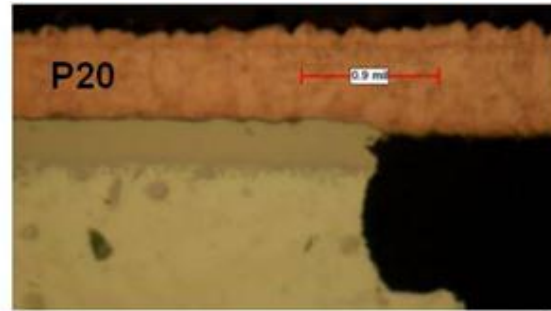
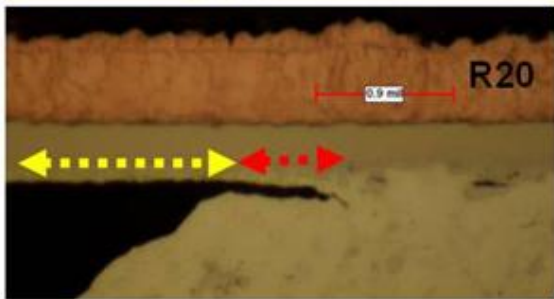
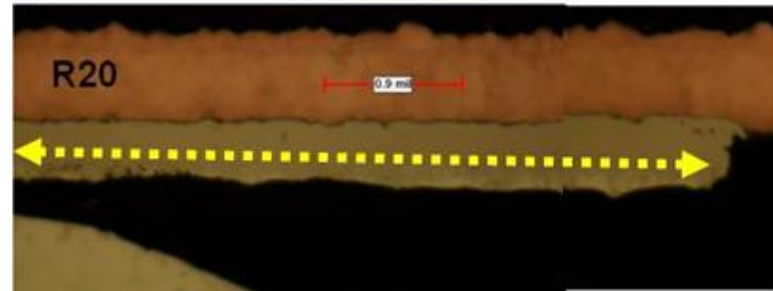
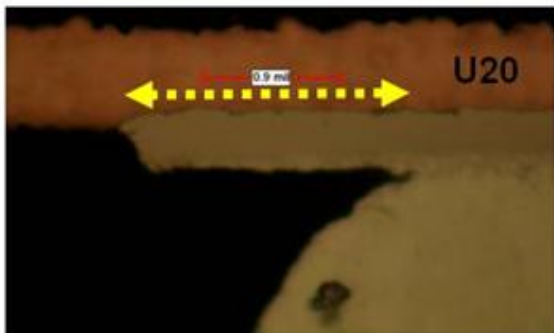
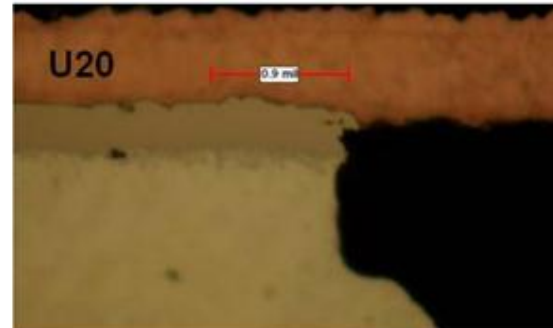
Magnified (1000X) cross section of PCBA, Component A, solder balls P20, R20 and U20.

At the dashed yellow lines, these look like de-wetting failures  
 At the dashed red lines, clear indications of fracturing are seen

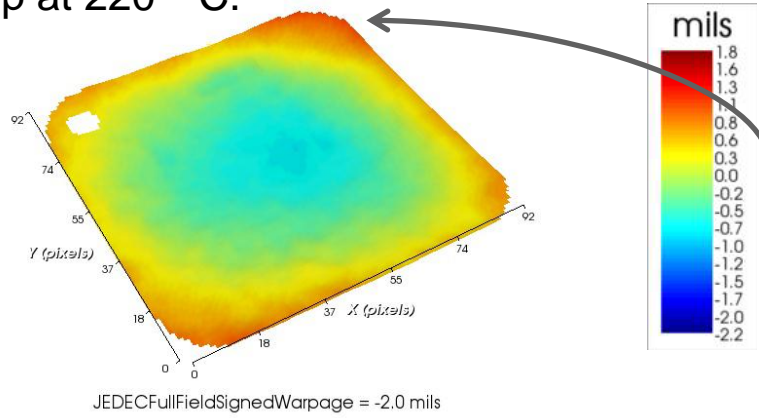
A warpage displacement map across the overmolded area of Component A measured during temperature ramp up at 220° C.

Corner with majority of failures

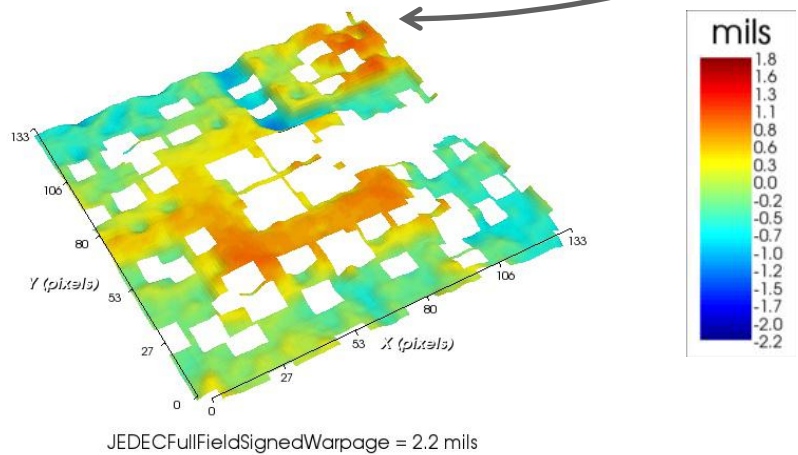
A warpage displacement map for the PCB footprint matching Component A. The measurements were made during temperature ramp up at 220° C.

- The thermal shadow Moiré data indicate a net displacement or warpage of Component A relative to the PCB of approximately 4 mils during heating in advance of melting or during cooling before solidification takes place (shaded Max.  $\Delta$  cells in Table 2).
- In most applications 4 mils of warpage would be considered acceptable because defects like HoP and dropped ball would not occur. On the other hand, solder assembly defects due to warpage can appear with deviations in warpage as small as a few mils.

The solder assembly process was changed to allow the BGA components to be assembled during the second reflow. This process change was successful in that it eliminated the Double Reflow Defects.
