Case Studies of Harsh Application Environments, the Unforeseen Situations

Christopher Genthe and Kelly Flanagan

Rockwell Automation

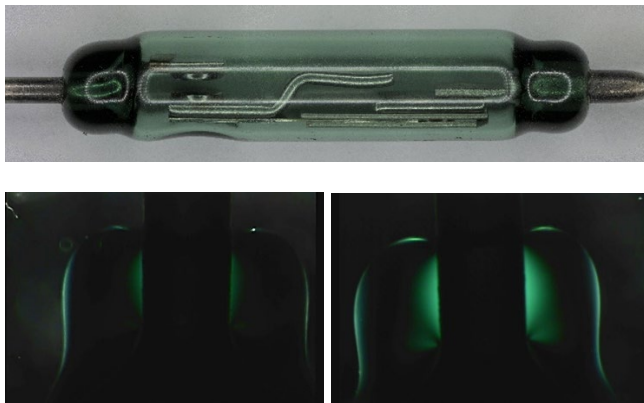
An anomaly occurred to the reed switch glass aboard an offshore oil platform that was being moved from the Caribbean to the Mediterranean Sea. When the platform arrived at the prescribed destination, it was noted that many of the switch assemblies were not functional. Upon return receipt, analysis indicated the glass envelopes had cracked, which allowed moist air into the envelope, corroding the electrical contacts which raised contact resistance past acceptable levels.

The initial assumption was that the glass cracking was a mechanical issue, thus various tests were devised and implemented with little success inducing the exact cracking mode. After eliminating other various mechanical inputs as the cause, investigation centered on residual tensile stress in the tube itself. A small amount of residual compressive stress is needed to maintain the glass to metal seal of the switch assembly. Another factor that also indicated a possible stress issue, was that the furnace used to temper anneal the glass after hermetic sealing had been moved and refurbished. Thus, samples of pre and post furnace move were analyzed using light polarimetry to quantify the amount of stress remaining in the seal areas. While a slight compressive stress is needed to maintain the seal, excessive amounts can lead to a form of stress corrosion cracking of the glass in moist environments. It was found that the pre move samples contained significantly less stress at the seals than the post move samples. A design of experiments was performed to compare furnace temperature, belt speed, and actual temperature of the switch assemblies on the anneal fixture. A comparison was also done of the furnace temperature profile both pre and post move (Figure 2).

Figure 1. Image of the switch contact assembly (top). Polarimeter images of the stress field at a glass seal on a unit retained from production prior to furnace move (left) as compared to a unit produced using the post move furnace recipe (right).

A test method was devised using a commercial pressure cooker to induce the cracking mechanism. It was found that the glass envelope would crack relatively quickly with heat and moisture when the anneal was not sufficient to reduce the residual stress to an acceptable level, yet still maintain the seal during cyclic thermal testing. After furnace adjustments, this test method was used to verify adequate glass tempering.

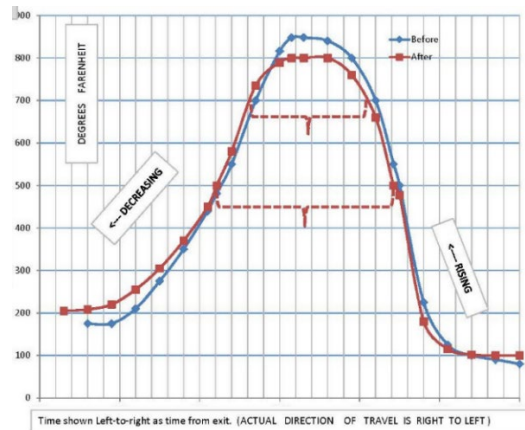
Figure 2. Furnace temperature profile comparing an earlier profile vs the later. The main issue was a ~50F peak temperature change.

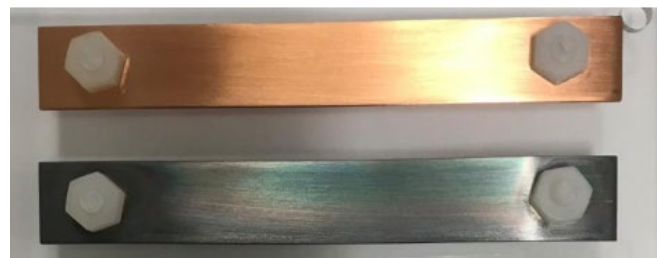
Figure 3. Image of the copper and silver coupons after exposure in the control room. The accelerated silver corrosion is typical of certain types of sulfur contamination in the environment.

for analysis. Elemental compositions and crystalline structures were identified using SEM/EDS or XRF, and XRD techniques. It was noted that the coupons showed no visible signs of copper corrosion and slight corrosion/tarnishing of the silver (Figure 3). Elemental analysis found elevated carbon on both sets of copper coupons and elevated sulfur on both sets of silver coupons. These results suggest a presence of some type of organo-sulfide compound in the contamination. Elemental mapping of the power module indicates the corrosion was likely a sulfide of copper (Figure 4). Growth of these corrosion products are typically driven by contamination concentrations, temperature, moisture levels, and the potential difference across the ceramic.

The likely source of the sulfur compounds within the control room was air handling. An investigation into plant exhaust airflow patterns found the external control room intake for “fresh” air was too close in proximity to the process fume exhaust. Process air was inadvertently being used to condition the control room, especially when the wind was blowing in certain directions. Filtration used on the HVAC system was meant for particulate, not gas phase contamination. Though the investigation was initially centered on cleaning chemicals, the investigation changed quickly once initial data was analyzed. Further investigation took some time, but resulted in positive changes for the customer.

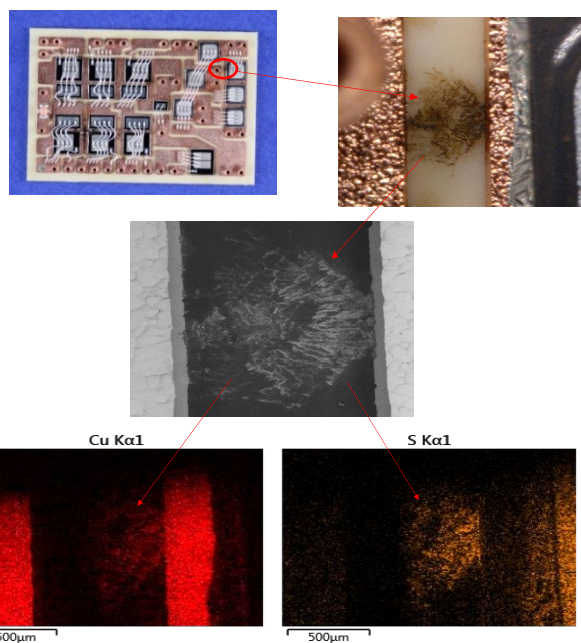
Environmentally controlled rooms have been used to protect industrial process control electronics operating in less than clean environments for a long time. Typically, these rooms have air conditioning systems that both cool and filter the air. Degradation of electronics in control rooms is typically rare, if the room was correctly constructed. Thus, finding degradation within power electronics in a control room was a surprise. The control room was in a manufacturing facility that was producing pet food, thus contamination typical of a washdown environment was expected, along with the corrosion mechanisms typical of high pH anti-bacterial chemistries. These type of degradation mechanisms were not found. The power module was found to be suffering from dendritic sulfide corrosion growing across ceramic substrates bridging isolation gaps.

Figure 4. Optical images, SEM backscatter image and EDS elemental mapping showing the morphology and elemental composition of the dendritic growth found growing across the ceramic isolation layers in the power device. Note, not all elemental maps included.

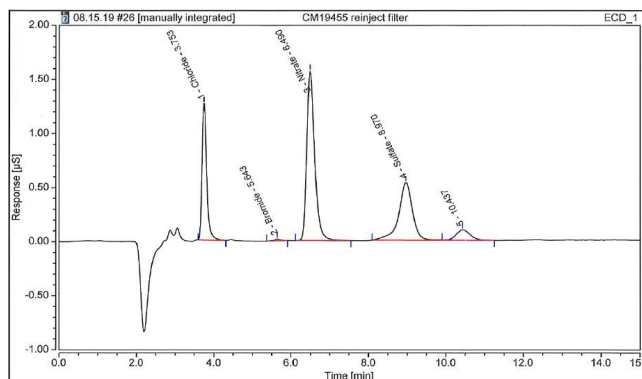
A portion of both the collected debris and filters were analyzed for ionic contamination using IC. Analysis identified ionics in the form of chloride, bromide, nitrate and sulfate (Figure 5). The presence of ionics would accelerate corrosion mechanisms and contribute to electrical issues if accumulated on unprotected electronics/circuit boards in the presence of an electrical potential and elevated atmospheric moisture. The problem was that general corrosion of the PCBAs or other areas of the drive were not found. Portions of the coupons, debris and filters were solvent extracted and analyzed for volatile compounds using GCMS. The filters contained a variety of hydrocarbons, fatty acids, silicones, and aldehydes, all which were not expected to contribute to the sulfur corrosion. Several amine compounds were found which were suspected of inhibiting corrosion of the copper. However, no volatile sulfur containing compounds were identified in the samples. This would suggest that the source

Figure 5. IC analysis results identifying the anions found in filter debris extraction.

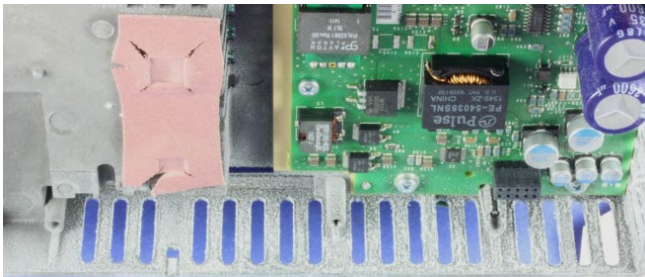
Initial testing of the returned units found them functional. During disassembly of the products, a large amount of white debris was noted across the entire exterior and interior of the magnesium chassis, as well as accumulated onto the internal PCBAs (Figure 6). Initially, moist sea air was identified as the problem. No signs of corrosion were found on the PCBA itself.

Figure 6. Image of the inside of one of the products as received, showing the metal chassis is covered by a white loose debris which appears to have accumulated onto the internal PCBA.

The intermittent issues were likely caused by ionics from corrosion products of the magnesium chassis accumulating onto the PCBAs combined with elevated moisture/humidity. Magnesium carbonate is a corrosion product of magnesium when exposed to high levels of moisture. The unusually high level of acetate was thought to be originating from the sealant used to seal the plywood crates the product was stored in. A byproduct of the curing of certain sealants (for example an acetoxy cure silicone) is acetic acid, which could form the acetate ion. This example highlights the unforeseen consequences of improper storage conditions.

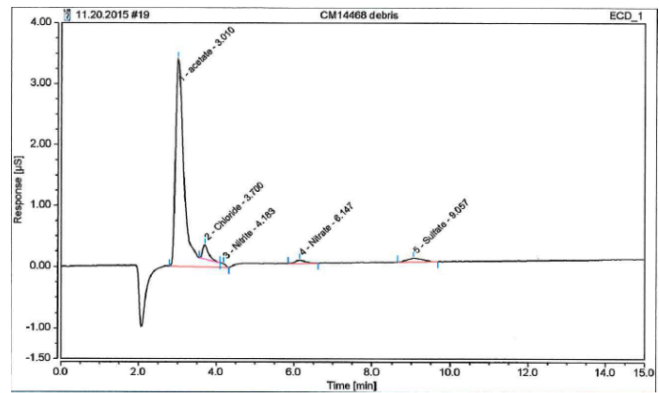
Elemental analysis of the contamination removed from the first chassis using SEM/EDS revealed high concentrations of oxygen, magnesium, carbon, sodium and aluminum; with lower levels of silicon, calcium, iron, chlorine, sulfur, potassium, zinc and chromium. IC analysis on the chassis and internal PCBA identified high levels on conductive ionic compounds with high levels of acetate and lower levels of chloride, nitrate and sulfate (Figure 7). Chloride would be expected in environments near the ocean and low levels of nitrate and sulfate can be found in general dust. Acetate is unusual to find, especially in the reported application environment. You might expect to find acetate in food manufacturing or washdown environments that would use acetic acid as part of the cleaning process. FTIR analysis identified the white debris as the salt of an organic acid confirming an acetate salt. XRD identified the crystalline species as a mixture of magnesium chloride, magnesium chloride acetate hydrate, magnesium acetate, and magnesium oxide.

Figure 7. IC analysis results identifying high levels of acetate.

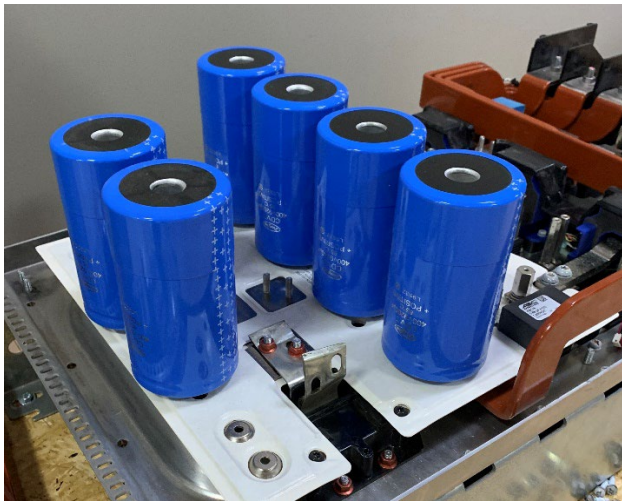
Upon further investigation, it was found that while the drives were cold, the airborne solvents could slowly absorb into the polyvinyl chloride (PVC) insulation wrapping on the electrolytic capacitors (Figure 8). When the drive suddenly warms up under a heavy load, the air-borne solvents evaporate on a much shorter time scale. Thermogravimetric analysis (TGA) demonstrated that transient solvent concentrations approaching the flammability limit were achievable within the drive enclosures as a result of the absorption-evaporation mechanism.

Figure 8. Representative image of drive capacitors

A second experiment demonstrated that when solvent molecules evaporate out of the PVC, an electrostatic charge separation also occurs. The buildup of separated charges in the drive enclosure therefore results in an eventual electrostatic discharge, which acts as an ignition source. The resolution was to convert the enclosures to a NEMA 12 type sealed enclosure to prevent air exchange with the application environment.

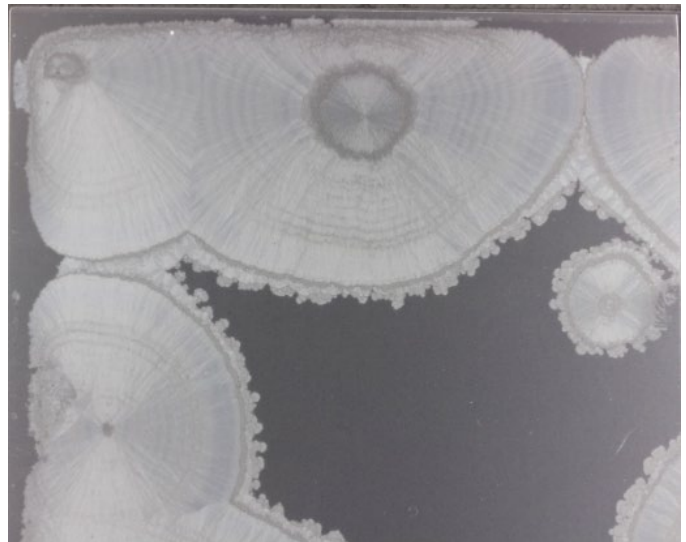
Multiple distributors were reporting what appeared to be crystal growth on the touchscreen display film of industrial computers when received across multiple date codes (Figure 9). The manufacturing plant that assembles these units did not report any issues during assembly. The touchscreen supplier sent samples to an independent laboratory who identified the cosmetic anomaly as a mold, *Aspergillus Restrictus*. Many of these products go into food and beverage applications and hospitals, environments with strict safety regulations. Thus, the returned units were provided with a request to either confirm or dispute the previous findings.

A portion of the film was sent to an independent microbiology laboratory which found the film negative for mold growth. Upon disassembly, viewed under magnification, the cosmetic anomalies appeared to be crystalline in structure nucleating from several points across the film. The crystals were found to be highly water soluble and easily extracted.

Figure 9. Image of cosmetic anomaly on diffuser film of returned computer.

In talking to the manufacturing location, it was determined that the operators were wiping down the displays with glass cleaner to remove any fingerprints on the display immediately before packaging. The ammonia in the glass cleaner sealed up with the left-over terephthalate acid on the film would form the ammonium salt of phthalic acid that was found on the surface of the film when the distributors received the product. The crystal growth was replicated by spraying a portion of new film with an ammonia-based cleaner and sealing it in a glass desiccator at room temperature for several days. The solution to the problem was

to have the operators clean with a non-ammonia based cleaner.

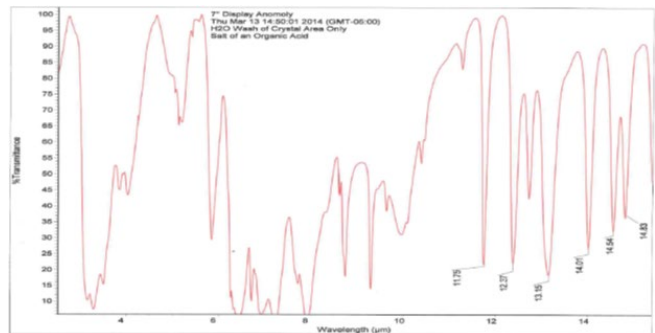
FTIR analysis confirmed that they were the salt of an organic acid and IC analysis confirmed phthalic acid was present (Figure 10), however SEM/EDS analysis could find no counter ion, which was strange. Raman spectroscopy performed at a local university found that the counter ion was likely ammonia, and the crystals were a good match to an ammonium salt of phthalic acid. The film was determined to be PET (polyethylene terephthalate), which is polymerized using terephthalate acid and butyl 1,4-butanediol. If the stoichiometry (ratio of starting materials) is off, excess terephthalate acid would be left on the film. But where was the ammonia coming from?

Figure 10. FTIR spectra of a water washing of the crystal area showing an ammonia salt of phthalic acid.

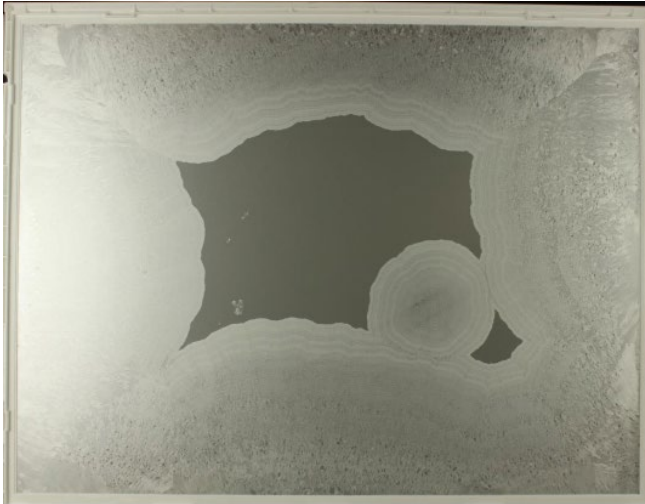
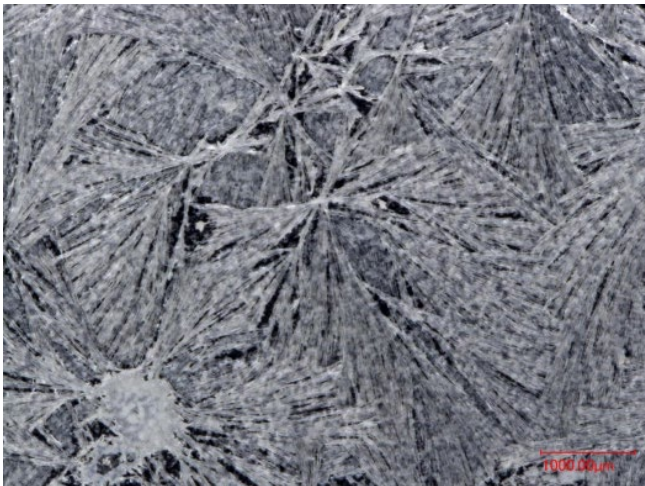
A few years later, more field returns were received with a similar cosmetic anomaly, but this time the displays had been in service for some time (Figure 11, 12). All the returns were from the food and beverage industry, specifically from beverage bottling lines. The initial assumptions were that it was the same issue and that the operators had resumed cleaning with an ammonia-based cleaner.

Figure 11. Image of anomaly on diffuser film of returned computer.

Figure 12. Image of anomaly on diffuser film under magnification.

This time, FTIR analysis of the crystals found bisphenol A and confirmed that the film material inside the display was a polycarbonate (PC). It was discovered that the film supplier had recently changed, and the film material had changed from a PET to PC. This change shouldn't have caused any issues, a plastic is a plastic after all. Bisphenol A is a monomer/starting material used in the polymerization of polycarbonate. PC is also susceptible to hydrolytic degradation with prolonged exposure to warm/humid environments, which results in a breakdown of the

polycarbonate to the bisphenol A monomer. The crystal growth was replicated in the lab by placing a sample of the film in a humidity chamber.

All the end use environments were found to use steam/high humidity as part of the sterilization process, which appeared to be accelerating the crystal growth on film that had excess Bisphenol A starting material. This anomaly appeared to be isolated to one lot of material and the issue never returned.

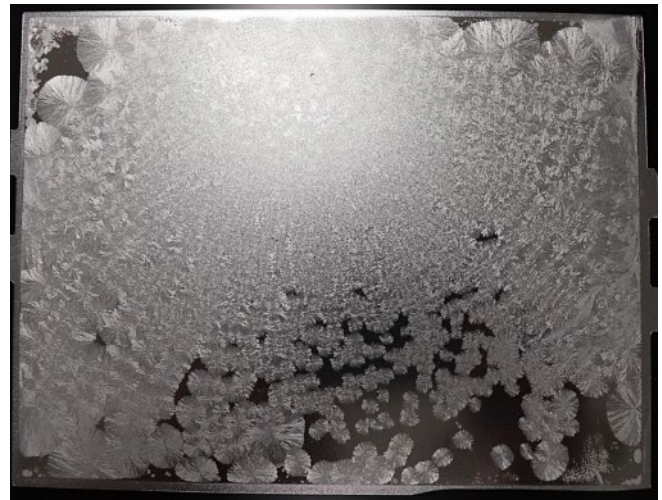
A few years later, more field returns with a similar cosmetic anomaly; this time the crystals, apparent on both the film and plastic bracketing, were noticed after the distributor received them but before being commissioned at customer sites (Figure 13). It was thought to be a storage issue, possibly high humidity based on the previous analysis. During conversations about the storage conditions, it was discovered that the distributor was placing VCI (vapor corrosion inhibitor) pucks in with the product during storage.

Figure 13. Image of anomaly on diffuser film of returned computer that had been stored with a VCI emitter.

FTIR analysis confirmed the crystals and film material were the same composition as the previous returns, bisphenol A and PC. This time the end use environments and storage conditions did not have high humidity. In evaluating the VCI emitter chemicals, it was discovered that one of the chemicals, 2-diethylaminoethanol, is incompatible with PC. The crystal formation was replicated by placing a sample of the film and bracketing in a sealed glass desiccator with the specific VCI emitter used. This analysis confirmed that this time the crystal formation, although the same chemical structure, was a result of chemical incompatibility. The VCI emitters were added routinely when product was stored to prevent corrosion of any exposed metal. While typically helpful, the chemicals used can have unintended negative reactions with some materials. The solution was to use a different VCI emitter with chemicals that were compatible with the plastics used in the product.

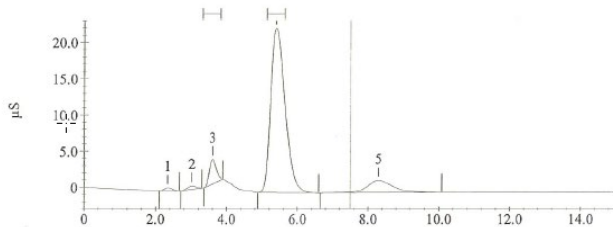
Figure 14. IC data indicating a significant amount of nitrate (peak 4).

Elemental analysis with EDS of the debris found a majority of carbon, oxygen, aluminum, silicon, calcium and iron, with smaller amounts of sulfur, chlorine, potassium, phosphorus, magnesium, sodium, titanium, manganese, and zinc. IC analysis in conjunction with XRD indicated the presence of several minerals, which is not unusual in a dust analysis, plus a significant amount of nitrate, likely sodium nitrate. Finding

Further investigation was required. The building was in an area that was surrounded by agricultural crops. Crop dusting was routinely performed. It was suspected that wind driven fertilizer was being drawn into the drive and the combination of the fertilizer and environmental moisture accelerated the corrosion mechanisms.

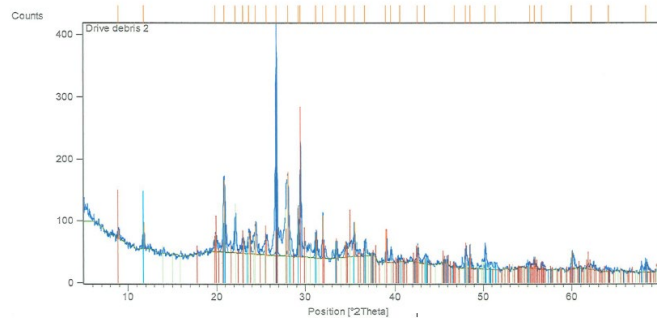
Figure 15. XRD data indicating the presence of sodium nitrate and gypsum, both which may be ingredients in a fertilizer.

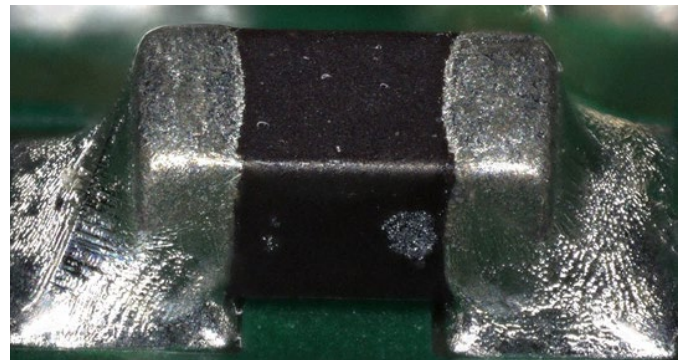
Figure 16. Optical image of a surface mount inductor showing corrosion mid-body through the epoxy coating.

What was found, after inspecting many resistors very carefully, both optically and in the SEM, was not an issue with the surface mount resistors, but rather with some surface mount inductors. Silver corrosion product was found on the surface of the epoxy molding. SEM/EDS analysis indicated the debris contained silver and sulfur, likely silver sulfide (Figure 17). The internal construction of the inductor uses silver, which was too close to the surface of the epoxy. The contaminant diffused into the outer coating, and corrosion occurred internally. The change in volume of the corrosion product cracked the case, which allowed direct access to the external environment, thus accelerating the degradation mechanism. The board was not conformally coated.

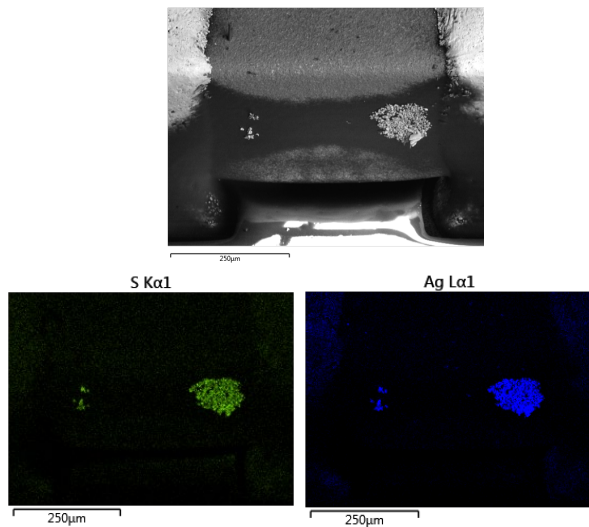
Figure 17. SEM backscatter image and EDS elemental maps of the inductor in question. Note, not all elemental maps included.
