In-Situ Thermal Radiographic Failure Analysis of Capacitor Encapsulant Fracturing

RTX- Raytheon

ABSTRACT

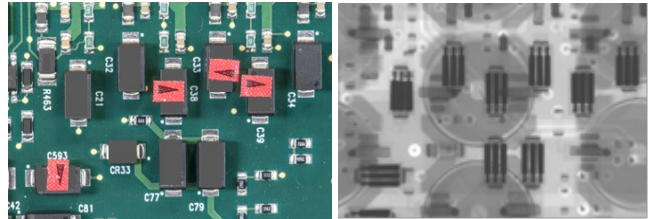
Multiple tantalum capacitors are SMT attached to PCBs. Failures or fractures were observed only at contractor SMT assembly lines and not on RTX lines. Although the CCA capacitors passed electrical tests, a fracture in the capacitor molding encapsulant may compromise the long-term reliability of the capacitor from exposure to moisture, cleaning solutions, corrosive or harsh environments.

Figure 1. CCA with multiple tantalum capacitors that fractured (L). X-ray was not able to discern fractures or any extraneous metal on or within mold encapsulant (R).

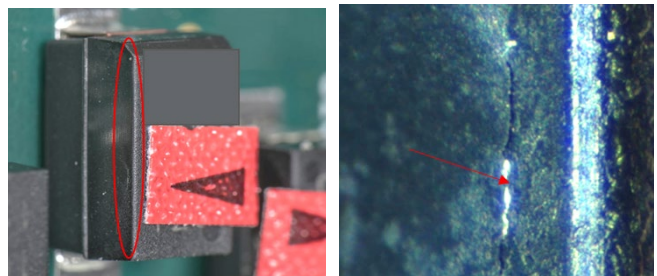
Figure 2. Capacitor (L) and at 10X magnification showed longitudinal fractures along the top and within the molded encapsulant with metal protruding from fractures (R).

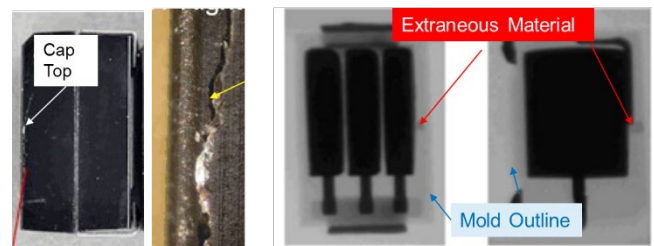
Contract assembler and component supplier performed analyses on tantalum capacitors. No as-received capacitors were found with any fractures. No assembly or internal anomalies were reported or observed on capacitors that fractured after SMT assembly. Fractures were attributed from the presence of moisture.^{[1][2]} However, upon revisiting x-ray images, extraneous material was observed on the top lead-frame within the molded epoxy.

Figure 3. OM-optical microscopy images of longitudinal fractures with metal protruding (L). X-ray images showed extraneous material on top lead-frame within molding (R).

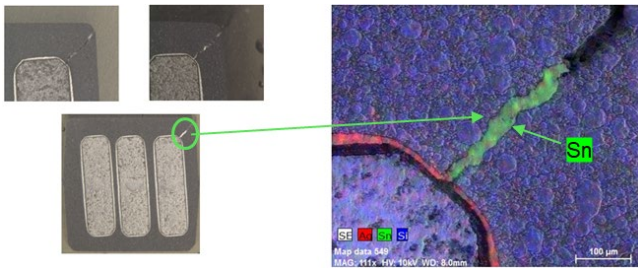
Figure 4. EDS- elemental dot map shows “Sn” in fracture of tantalum capacitor molding encapsulant (R).

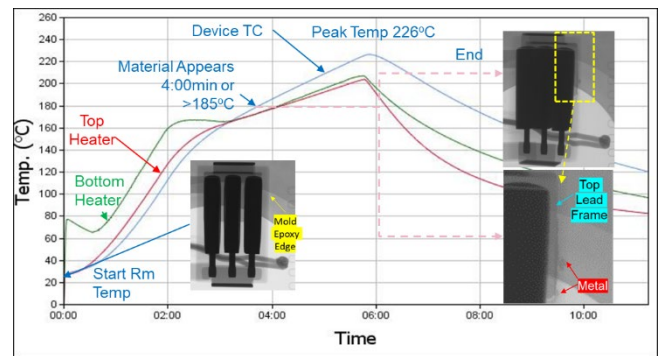
Figure 7. X-ray hot-stage top / bottom heaters and capacitor temperature vs time thermal profiles on 1 device. TC-thermocouple attached on back side of PCB. Material formed on top lead-frame edge, underneath the mold epoxy surface ~ 4:00min, ~185°C .

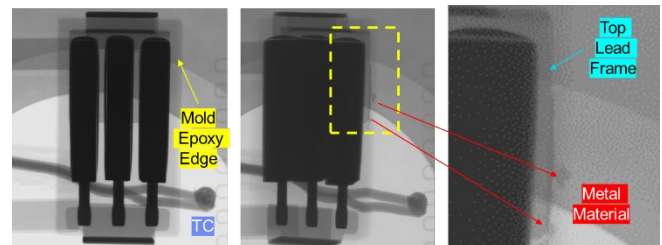
Figure 8. Closer views of capacitor before (L) and during simulated reflow on x-ray machine hot-stage (C, R). Material formed along the of the top lead frame < 232°C.

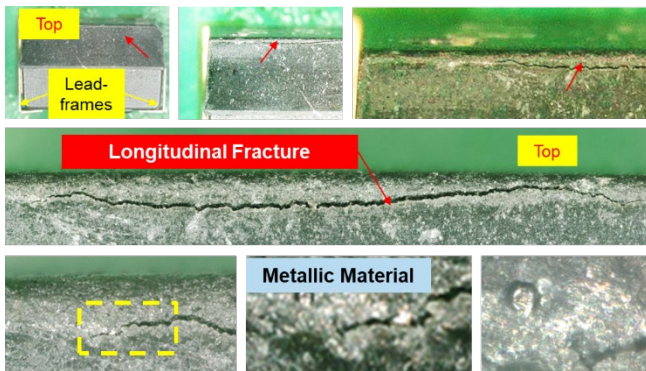
Figure 9. After reflow in X-ray machine. Increasing magnification views show longitudinal fractures were replicated along the top surface within the molded encapsulant with metal observed within the fracture as in previous production failures.

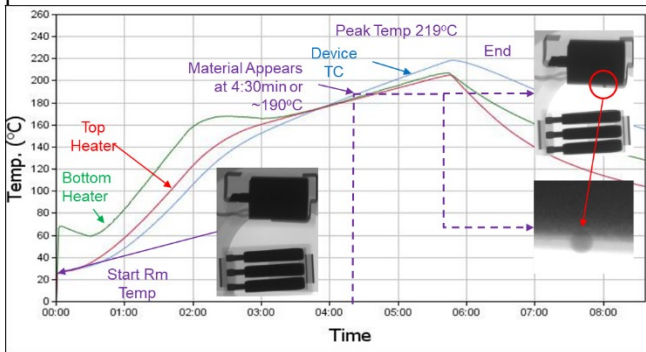
Figure 10. X-ray hot-stage top / bottom heaters and capacitor temperature vs time thermal profiles on 2 devices. Material appeared on top lead-frame edge, underneath the mold epoxy surface ~4:30min, ~190°C .

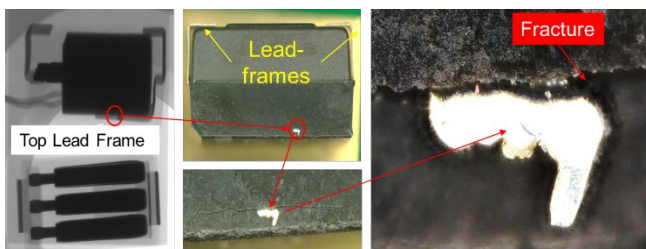
Figure 11. X-ray image after 2nd SMT reflow replicated failure (L). Shows as-received capacitor lead-frames with a longitudinal fracture along the top lead-frame (C). Closer view shows a metallic material emerging from the fracture as observed in previous production failures (R).

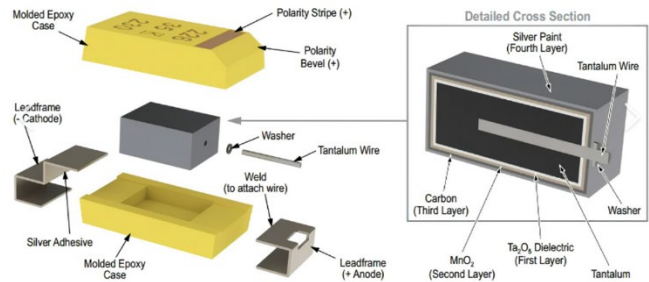
Figure 12. Representative tantalum construction tantalum for reference. Note Ag-silver adhesive used on the lead-frame that was later confirmed to be Sn (tin) plated.

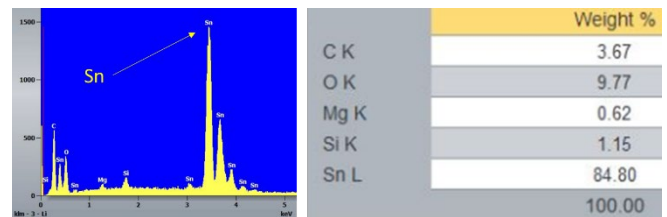
Figure 13. EDS-energy dispersive spectra of the tantalum capacitor lead-frame surfaces, that are SMT reflow attached to PCB pads. Predominantly a Sn surface.

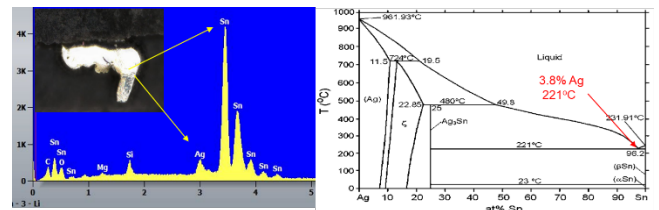
Figure 14. EDS chemical analysis spectra of the metallic material protruding from the longitudinal fracture showed small amounts of Ag along with mostly Sn (L). Ag-Sn phase diagram shows a low temperature Sn-Ag 3.8% eutectic alloy can form ~221°C (R).

Although Ag melts ~ 962°C and Sn melts at 232°C, a small amount of Ag from the Ag-adhesive, formed a Sn-Ag 3.8% eutectic alloy with the top Sn-plated lead-frame ~221°C.

The tantalum capacitor's top lead-frame most likely experienced higher temperatures given its proximity to the top heater and not as thermally protected as the middle lead-frame, where the Ag-Sn alloy formed, expanded and fractured the mold epoxy along the top lead frame in a longitudinal manner.

A slightly lower SMT RF profile temperature thus far, has mitigated this fracture phenomena.
