PERM DoD Consortium Phase 3 Pb-free Solder Thermal Cycle Reliability Results Comparing Different Levels of Bismuth Alloying

Tim Pearson, David Hillman, Ross Wilcoxon,
Julie Mills, Leela Herena
Collins Aerospace
IA, USA
Timothy. J. Pearson@collins.com

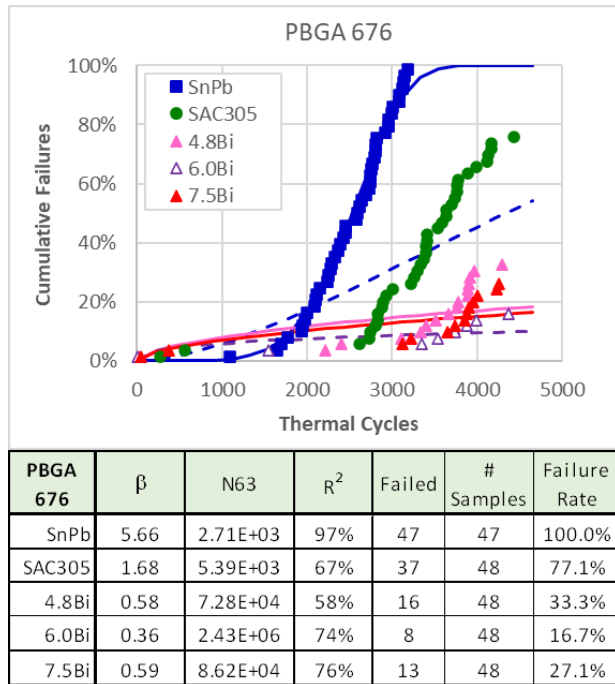
Figure 12: PBGA-676 Statistics by Solder Alloy, All Failures

The PBGA-676 components had accumulated 50.6% population failure after the completion of 4362 thermal cycles. SnPb had the highest failure rate at 100% failure, followed by SAC305 at 77.1% failure, while SAC6.0Bi had the lowest failure rate at 16.7%. All of the SACBi alloys performed better than SnPb and SAC305, with most failures occurring after 3000 cycles. Figure 12 and Figure 13 summarize the PBGA-676 thermal cycle test results. Again,

the first plot shows all failure data while the second figure shows filtered data that only includes failures that occurred after 600 thermal cycles to eliminate infant mortality effects from the overall population trends.

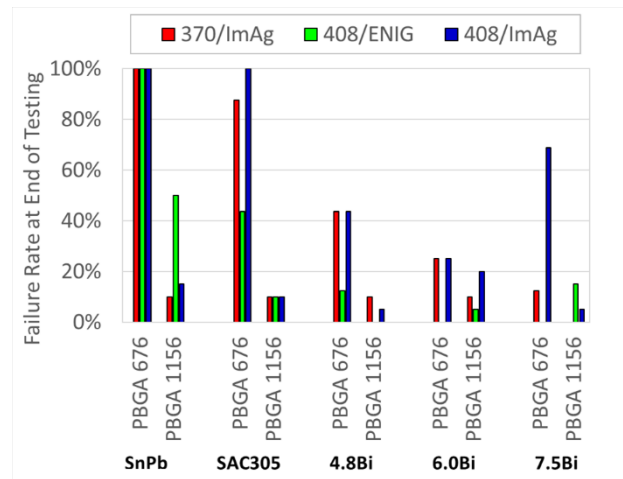
Figure 20: Overall Failure Rate for PBGA Packages with Different Board/Surface Finish/Solder Alloy Combinations

The specific combination of solder alloy, laminate and surface finish did affect reliability, as illustrated in Figure 20. This compares component failure rates for the two PBGAs when testing finished. In each case, more of the smaller PBGAs had failed by the end of testing. In most cases, results were similar for the two laminate materials and in only two out of ten Component/Solder combinations the ENIG surface finish led to higher failure rates.

The impact of board laminate and surface finish on the failure rates of these two BGA packages corresponds to slightly higher stress in the board and reduced compliance in the solder, which exacerbates the increased stress effects induced by the larger die in the smaller package. This will be discussed further in a later section of this document in which the influences of laminate and surface finish on component reliability are discussed.

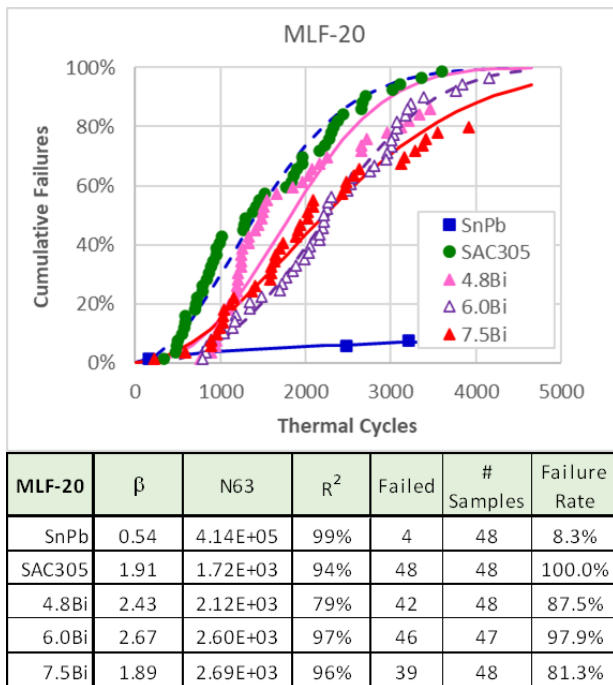
Figure 28: MLF-20 Statistics by Solder Alloy, All Fails

The MLF-20 components had accumulated an overall 74.9% population failure after the completion of 4362 thermal cycles. For this component type, SnPb performed significantly better than all of the other alloys, with only 8.3% failure, while all of the SAC alloys amassed over 80% failure. Published results showed that a QFN- 48 package with SnPb solder alloy performed better than a SAC405 solder alloy in 0°C -100°C thermal cycle test conditions [9]. Note that QFN (quad flatpack no-lead) and MLF are different terms for essentially the same package style.

Figure 28 and Figure 29 summarize the MLF-20 thermal cycle test results, again for all data as well as with early (infant mortality) failures removed.

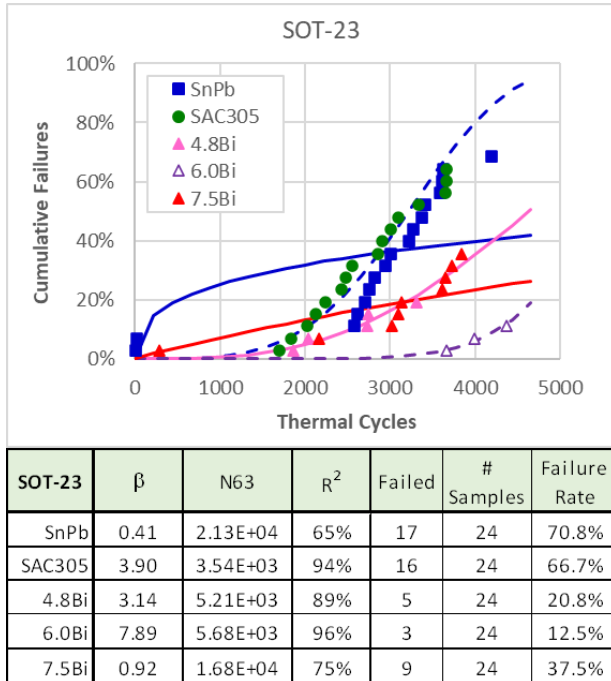
Figure 38: SOT-23 Statistics by Solder Alloy, All Fails

Overall, 42% of the SOT-23 components failed after 4362 thermal cycles. The SACBi alloys performed better than the SnPb and SAC305. The SAC6.0Bi alloy performed significantly better than the others, with no failures until after 3500 cycles and an overall 12.5% failure rate.

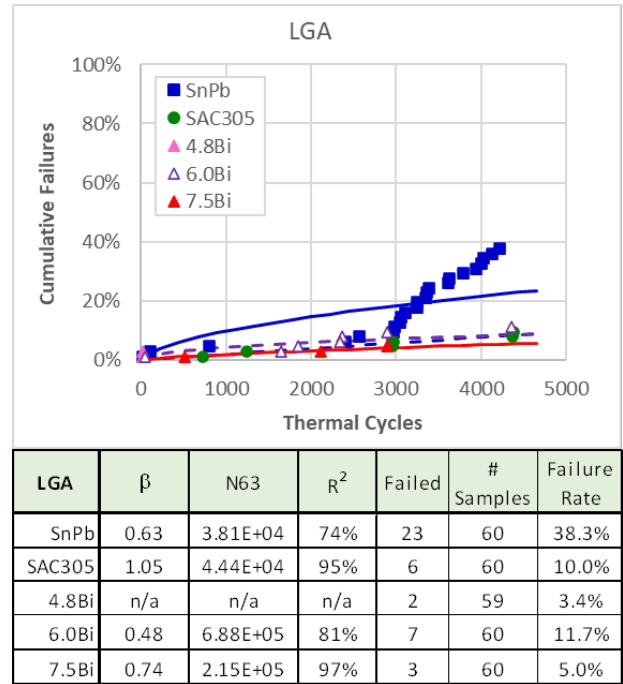
Figure 52: LGA Statistics by Solder Alloy, All Fails

cycles. SnPb had the highest failure rate at 38.3% failure, while SAC4.8Bi and SAC7.5Bi had the lowest at 3.4% and 5% respectively. While all the alloys had low failure rates, the Pb-free alloys performed better than SnPb.

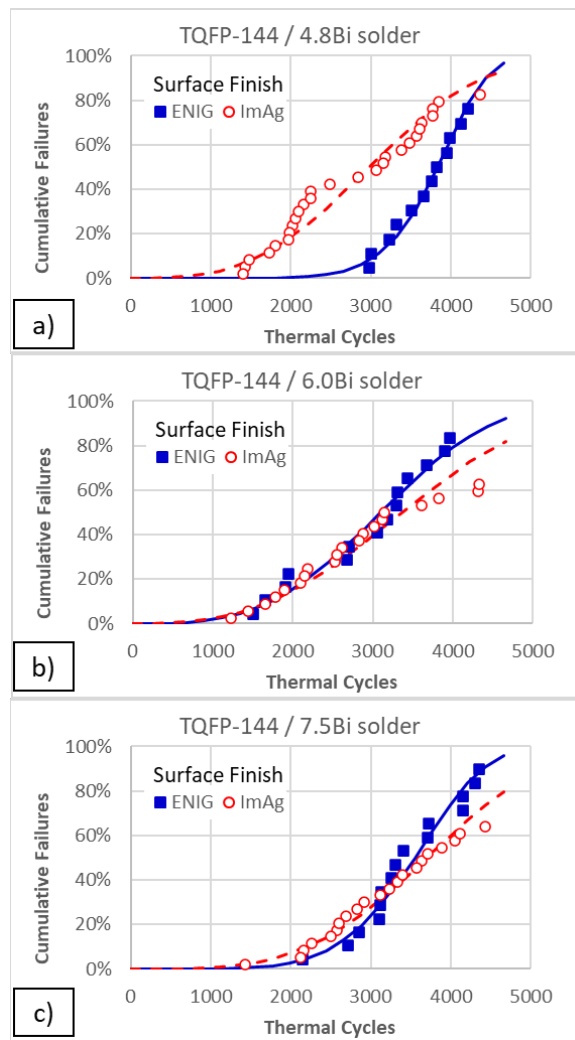
Figure 61: TQFP-144 reliability results for ENIG compared to ImAg - Not Including Early Failures; a) SAC4.8Bi, b) SAC6.0Bi, c) SAC7.5Bi

- The SACBi solder alloys had minimal board surface finish bias across the various components in the investigation (Figure 61). The one exception to this trend was the SAC4.8Bi solder alloy, which performed better with the ENIG surface finish (Figure 61 a).

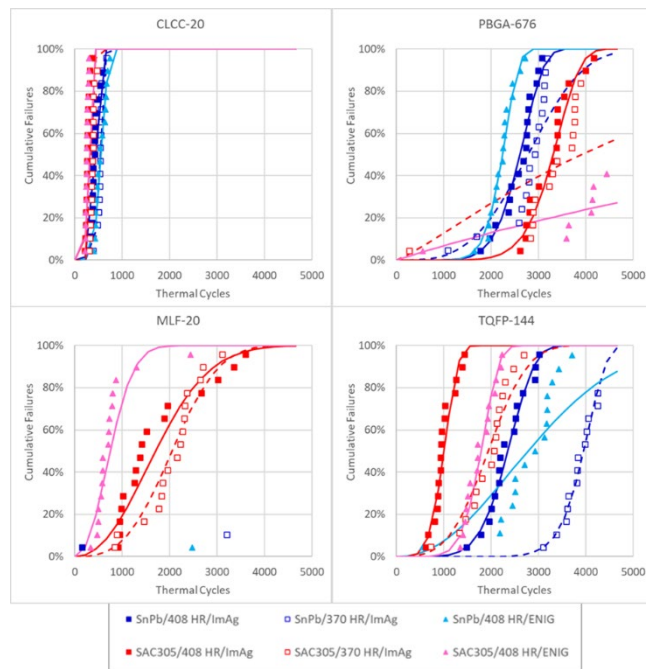
Figure 62: Effect of Laminate/Surface Finish Combination for SnPb and SAC305 Solders

Figure 62 and Figure 63 show results for the four components that exhibited the most failures by the end of testing (CLCC-20, MLF-20, PBGA-676 and TQFP-144). Each plot compares results for two solder alloys; Figure 62 shows results for SnPb and SAC305 solder while Figure 63 shows results for two of the SAC solder alloys with Bismuth, SAC6.0Bi and SAC7.5Bi. In all these plots, the two prime colors (blue and red) indicate a specific solder alloy. Solid lines/filled symbols show results for components assembled to test boards fabricated with 370HR laminate while dashed lines/open symbols correspond to 408HR. Dark blue and red indicate data for ImAg surface finish and their brighter counterparts (cyan and pink) show results for ENIG surface finish.

The results demonstrate that there were interaction effects for reliability of a given component / solder / laminate / surface finish combination. The CLCC-20 components exhibited low reliability that was insensitive to the other treatments. The PBGA-676 components with 408HR laminate tended to have higher failure rates with more compliant SnPb and SAC305 solders. However, with the bismuth solder alloys, the components on 370HR boards tended to fail earlier. The MLF-20 components likewise had somewhat lower reliability with the 370HR boards, but only with the SnPb and SAC305 solder alloys. With those solder alloys, the TQFP-144 tended to have lower reliability with the 408 HR laminate, but other components and the bismuth-based solders with that component did not exhibit the same trend.
