Drop Test Performance of A Medium Complexity Lead-Free Board After Assembly and Rework

P. Snugovsky, J. Bragg, E. Kosiba, M. Thomson, B. Lee, R. Brush, S. Subramaniam, M. Romansky
Celestica International Inc.

Abstract

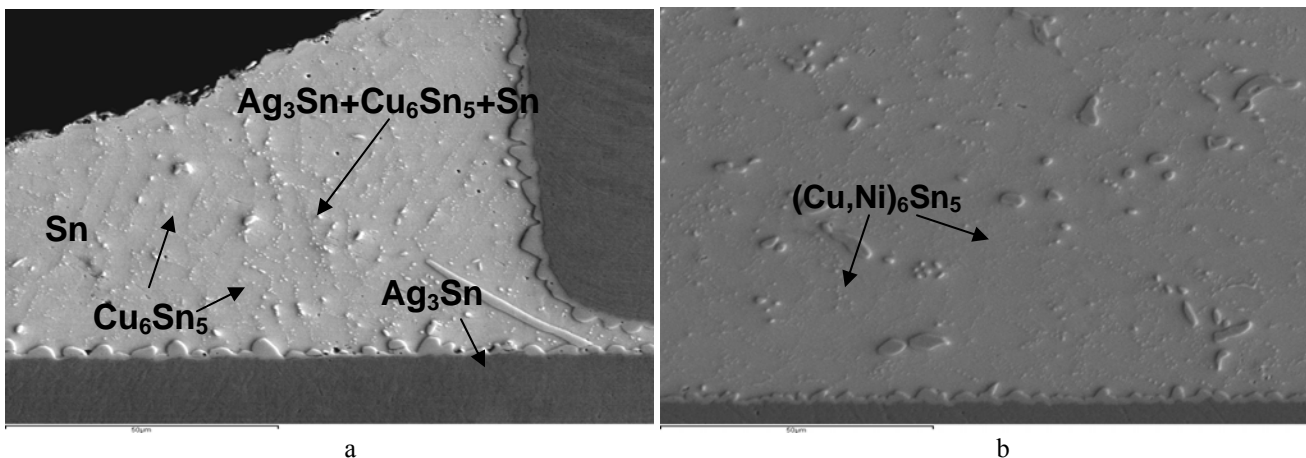
Figure 5 shows the microstructure of Pb-free joints before rework. The joints consist of highly branched primary-like Sn dendrites, and $\text{Ag}_3\text{Sn}+\text{Cu}_6\text{Sn}_5+\text{Sn}$ eutectic in interdendritic spaces and between the Sn dendrite arms. Both primary Ag_3Sn platelets and Cu_6Sn_5 were identified by EDX in the TQFP-144 solder joints. Relatively small Ag_3Sn platelets were attached to the pad intermetallic layer. No Ag_3Sn primary platelets were detected in the TSOP-50 solder joints. The primary intermetallic particles in these joints were Cu_6Sn_5 type that contained about 2% Ni and in some cases about 1% Fe. The sources of the Ni and Fe atoms were the Ni barrier layer and the Alloy 42 lead-frame material of the TSOP-50 components. The intermetallic formed between the Cu pads and solder in TQFP-144 and TSOP-50 was rather thin, 1.8 to 2.9 microns, and was of the Cu_6Sn_5 type.

Figure 5: Typical microstructure of SAC305 solder joints before rework, SEM 1000x: a-TQFP-144; b-TSOP-50
