# Double Reflow-Induced Brittle Interfacial Failures in Pb-free Ball Grid Array Solder Joints

This paper describes and characterizes electrically intermittent, brittle interfacial solder joint failures in a Pb-Free ball grid array (BGA) subjected to two reflow cycles. The failed BGA is a 1.27 mm pitch, perimeter array with a body size of 31 mm and SAC305 (Sn3.0Ag0.5Cu) solder balls. Due to the presence of several surface mounted daughter card modules on the non-BGA side of the board, the BGA-side of the printed circuit assembly was soldered first. In effect, this constraint put the BGA components atypically on the bottom-side during the second reflow. The solder joint failures were characterized with metallographic cross sectional analysis using optical microscopy and scanning electron microscopy. The failure mechanism and possible root cause are discussed in terms of the combined impact of stress induced by component and board warpage and the lower inherent strength of the solder joint near the melting and solidification temperatures. The primary objective of this work is to document this new case of Double Reflow failure to enable a heightened awareness of the failure mode. Thes

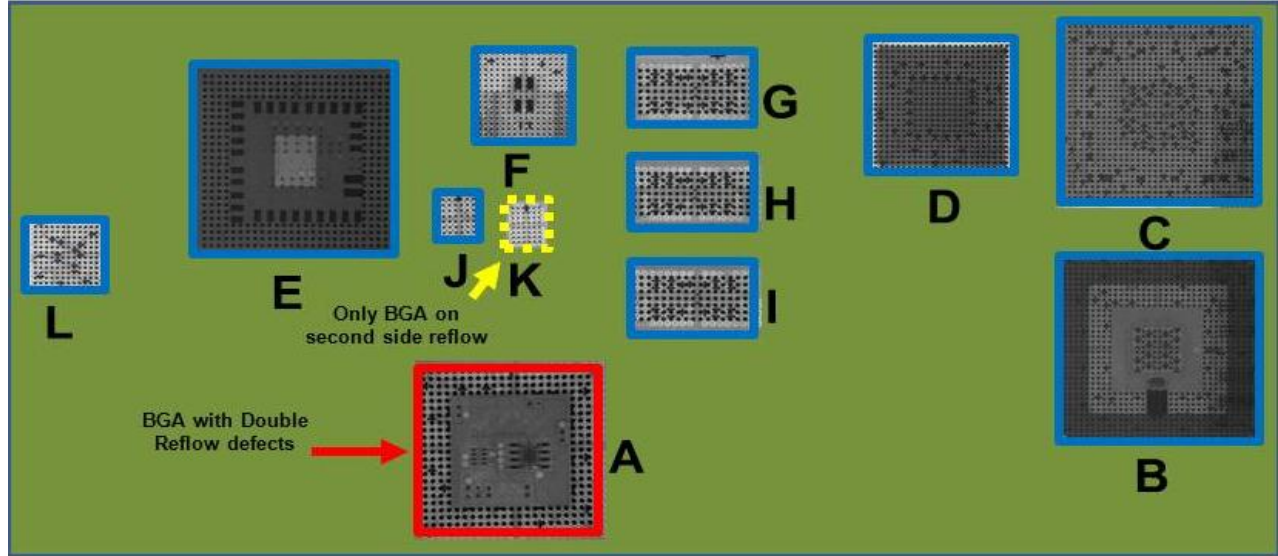
Figure 1: PCBA BGA Component Descriptions, Locations and Reflow Process.

with the exception of Component K were subjected to two reflow cycles. Due to the properties of the printed circuit board (PCB), soldering was done using two vapor phase reflow cycles, instead of the more typical hot air convection reflow cycles. Following the second reflow, the assembly exhibited parametric failures at test. The parametric failures were traced to the plastic ball grid array component (PBGA) labeled Component A and designated by the red box in Figure 1. Component A, which is a perimeter array BGA, 31 mm<sup>2</sup>, 304 I/O solder balls of 1.27 mm pitch and 0.76 mm diameter, exhibited intermittent solder joint electrical opens. There were no indications of solder joint electrical opens on any of the other components on the PCBA.

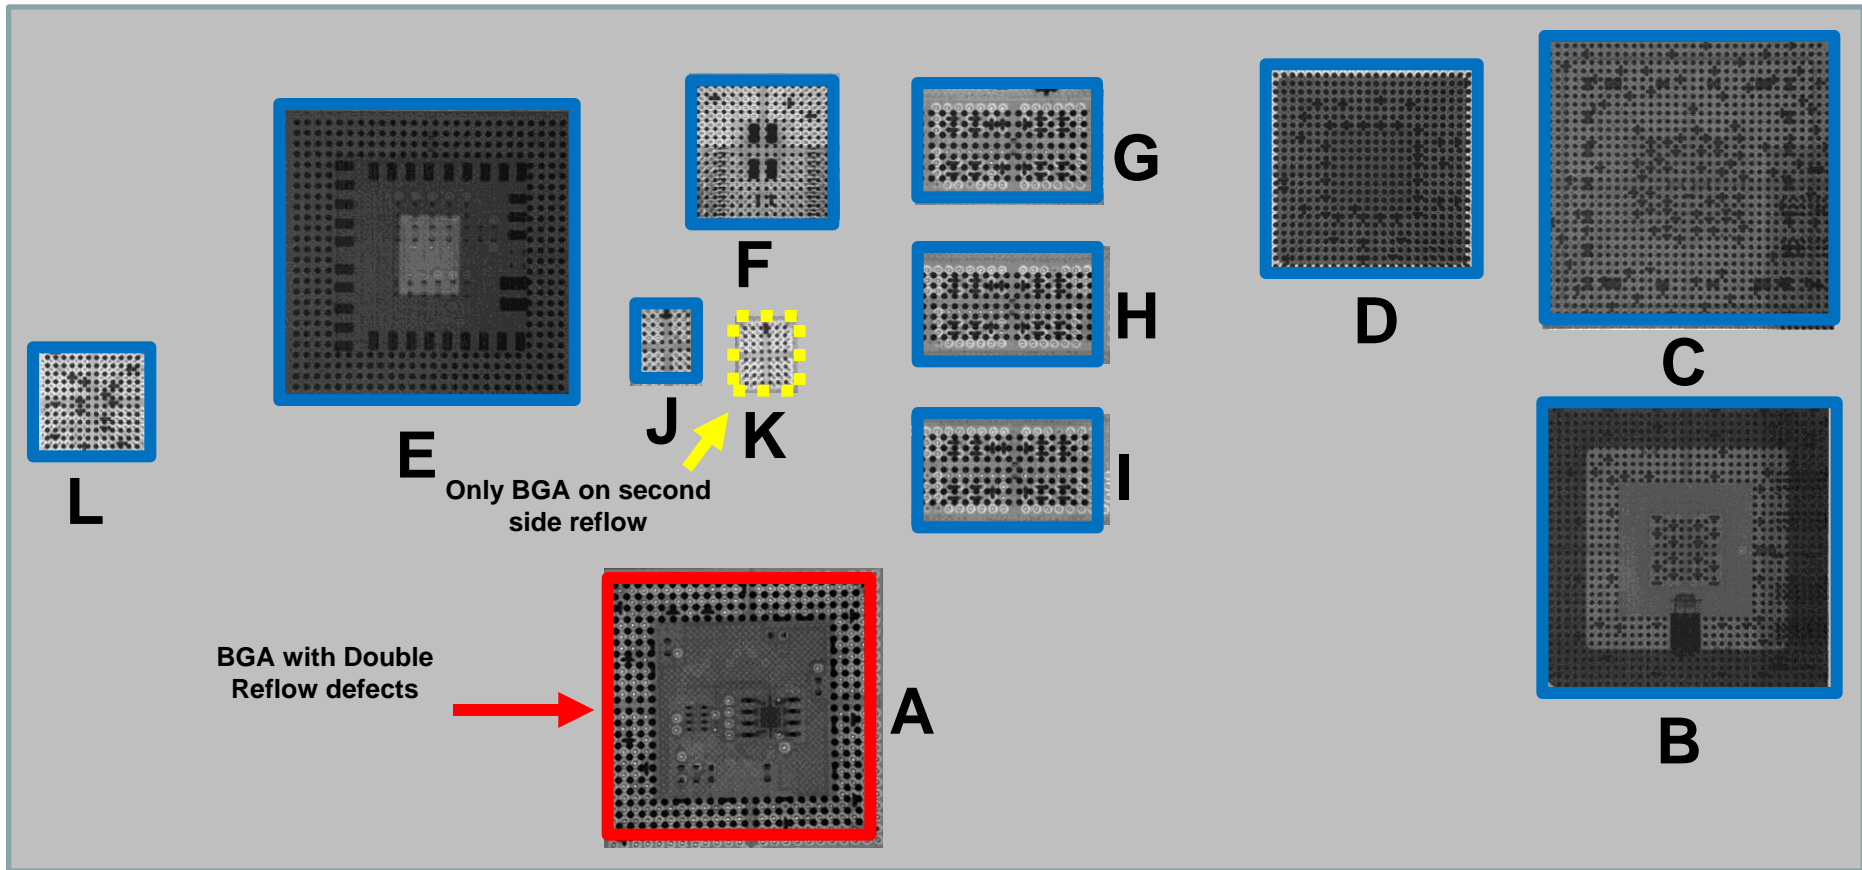
### Layout of the PCBA

All the BGA components, with the exception of Component K, were subjected to two vapor phase reflow cycles.

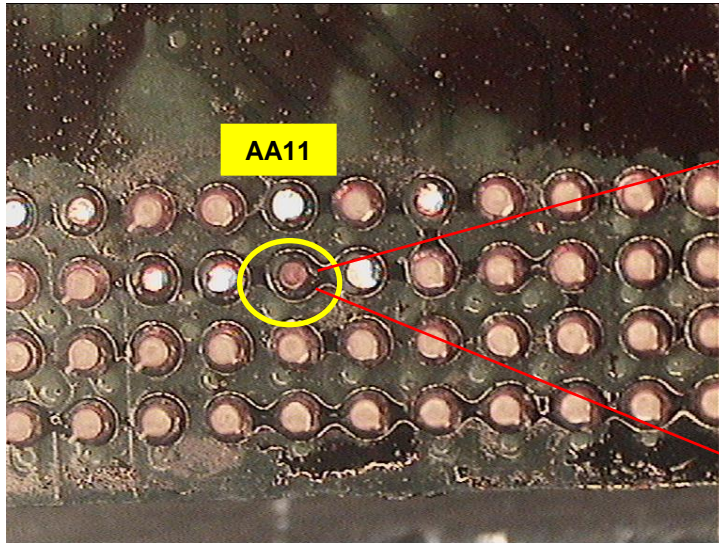
Component A, PCB side.

## Dye & Pry analysis Component A
