In-Situ Thermal Radiographic Failure Analysis of Capacitor Encapsulant Fracturing

RTX- Raytheon

ABSTRACT

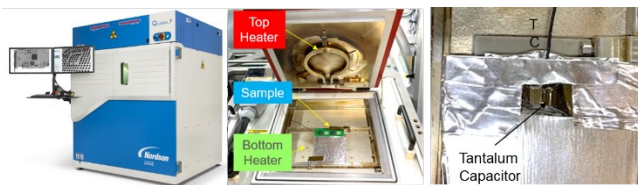
Figure 5. X-ray machine w/ hot-stage inside (L). The hot-stage has a top heater element and a bottom ceramic heater (C). TC-thermo-couple was attached to the back-side of 1 mm thick PCB, opposite device. Other areas not of interest were Al-aluminum thermal tape protected (R).

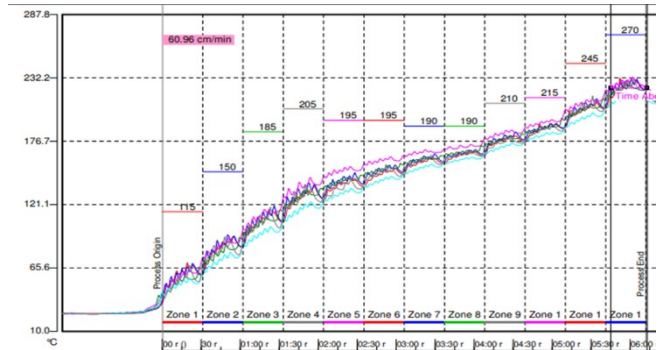
Figure 6. Actual production in-line SMT thermal reflow profile used to base the in-situ simulated thermal reflow profile on X-ray hot-stage.
