PERM DoD Consortium Phase 3 Pb-free Solder Thermal Cycle Reliability Results Comparing Different Levels of Bismuth Alloying

Tim Pearson, David Hillman, Ross Wilcoxon,
Julie Mills, Leela Herena
Collins Aerospace
IA, USA
Timothy. J. Pearson@collins.com

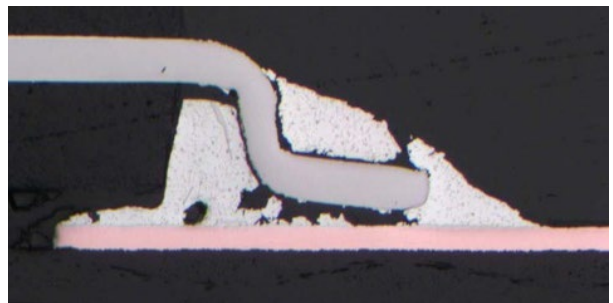
- The cracks in the solder joints initiated in the heel fillet region and traversed under the foot towards the lead toe. The crack formation and location are in agreement with industry knowledge of Alloy 42 lead material/TSOP failure modes [12].
- The solder joint geometries and wetting angles were acceptable and met industry workmanship criteria (IPC-J-STD-001). There were a number of instances where the solder did flow into the upper lead bend region. In most cases, this condition is acceptable per the IPC-J-STD-001/IPC-A-610 specifications.
- The solder joint microstructures were homogenous and uniform. SnPb solder joint microstructure coarsening was observed due to CTE mismatch between the solder and the Alloy 42 lead of the SOT-23.

Figure 42: SOT-23 SAC4.8Bi Solder, Failed at 2741 Cycles

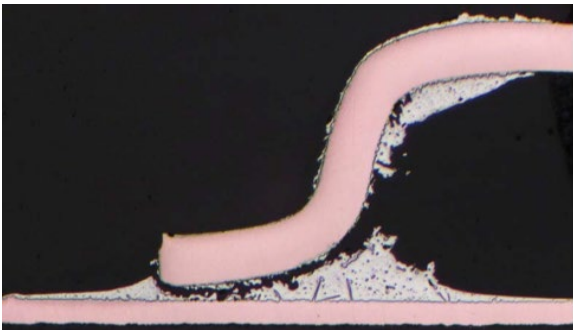
- Solder joint cracks initiated in the heel fillet region and traversed under the foot towards the lead toe. The crack formation and location align with industry knowledge of TQFP failure modes [6].
- Solder joint geometries and wetting angles were acceptable and met industry workmanship criteria. In multiple instances, solder did flow into the upper lead bend region, which is acceptable per industry standards.
- The solder joint microstructures were homogenous and uniform. SnPb solder joint microstructure coarsening was observed due to CTE mismatch between the solder and the copper lead base metal of the TQFP-144.

Figure 48: TQFP-144 SAC305 Solder, Failed at 629 Cycles

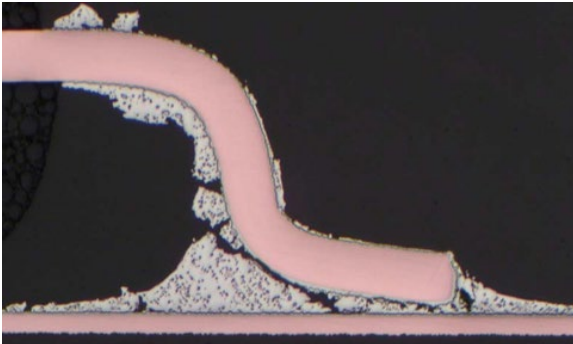
Figure 49: TQFP-144 SAC4.8Bi Solder, Failed at 121 Cycles

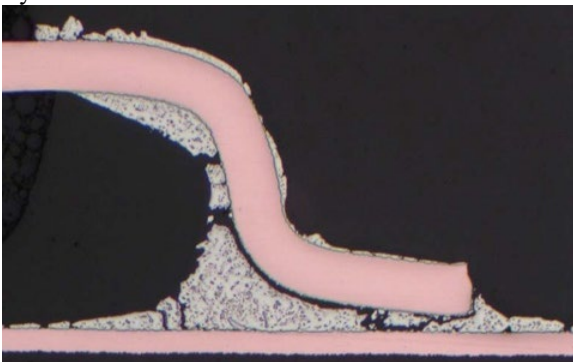
Figure 50: TQFP-144 SAC6.0Bi Solder, Failed at 383 Cycles

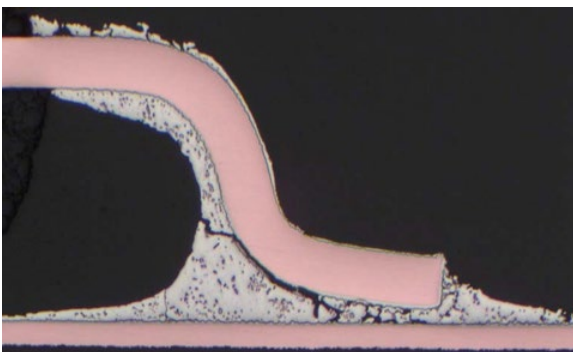
Figure 51: TQFP-144 SAC7.5Bi Solder, Failed at 3123 Cycles
