PERM DoD Consortium Phase 3 Pb-free Solder Thermal Cycle Reliability Results Comparing Different Levels of Bismuth Alloying

Tim Pearson, David Hillman, Ross Wilcoxon,
Julie Mills, Leela Herena
Collins Aerospace
IA, USA
Timothy. J. Pearson@collins.com

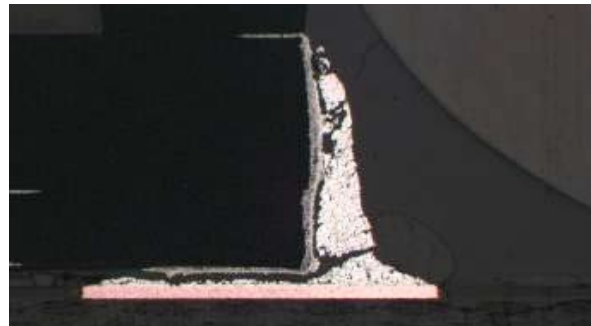
- Solder joint cracks initiated under the components and traversed at a $\sim 45^\circ$ angle through the solder fillets. The crack formation and location agree with industry published data of typical CLCC failure modes [7, 8].

Figure 23: CLCC-20 SnPb Solder, Failed at 328 Cycles

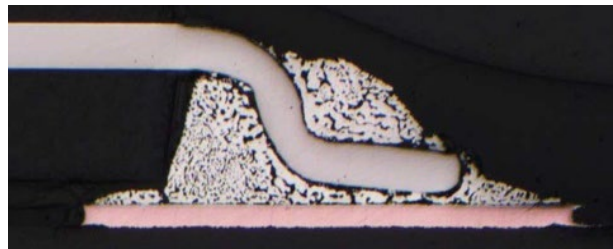
- The cracks in the solder joints initiated in the heel fillet region and traversed under the foot towards the lead toe. The crack formation and location are in agreement with industry knowledge of Alloy 42 lead material/TSOP failure modes [12].
- The solder joint geometries and wetting angles were acceptable and met industry workmanship criteria (IPC-J-STD-001). There were a number of instances where the solder did flow into the upper lead bend region. In most cases, this condition is acceptable per the IPC-J-STD-001/IPC-A-610 specifications.
- The solder joint microstructures were homogenous and uniform. SnPb solder joint microstructure coarsening was observed due to CTE mismatch between the solder and the Alloy 42 lead of the SOT-23.

Figure 40: SOT-23 SnPb Solder, Failed at 3004 Cycles
